Polyethylene liner fracture in dual-mobility trapeziometacarpal joint
prosthesis: Report of 17 cases

Polyethylene liner fracture in dual mobility trapeziometacarpal joint prosthesis: Report of 17 cases

We report 17 polyethylene liner fractures in 15 patients with dual-mobility trapeziometacarpal joint prostheses, primarily active males with high key pinch strength. Treatment involved head and liner exchange or trapeziectomy, depending on implant damage severity.

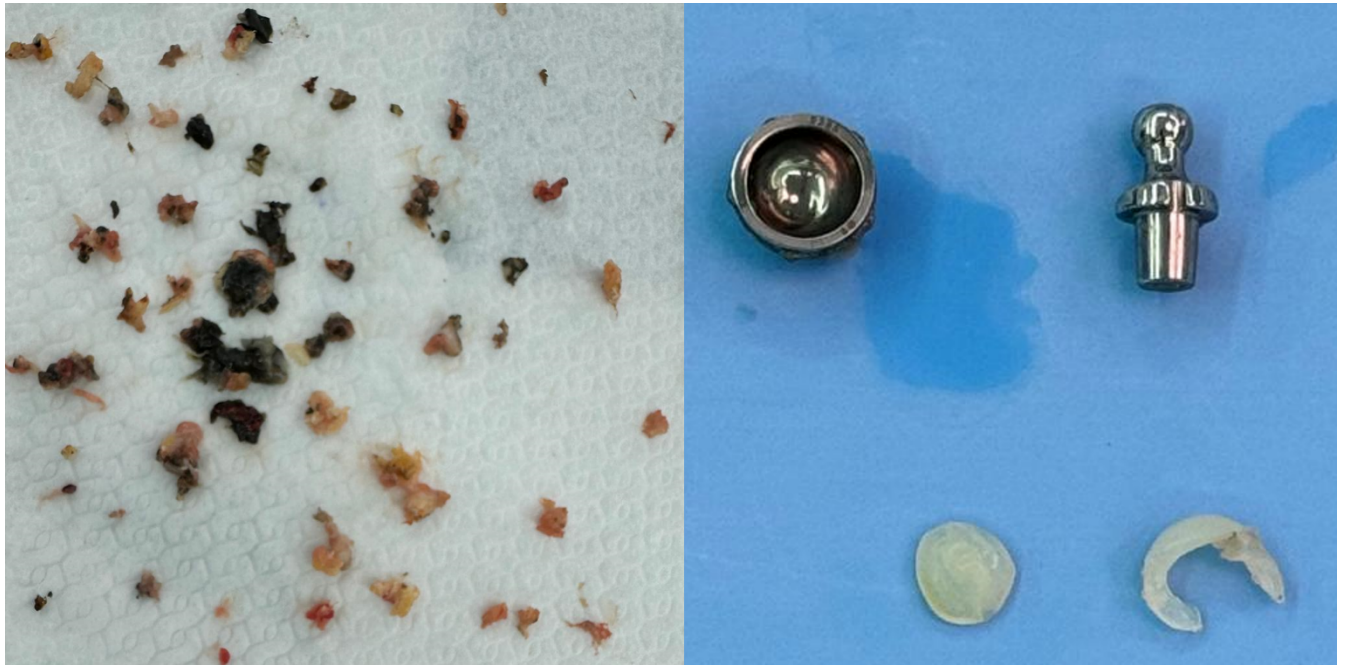
Figure 1. Severe metallosis (left) and broken polyethylene liner (right) 2.6 years after primary implantation in a 48-year-old male manual worker.
