Validation of a signalization scheme for road works at a roundabout (simulator study)

**MOLLU Kristof – Agency for Roads & Traffic /
Hasselt University**

Presented at Road Safety and Simulation 2017 – The Hague

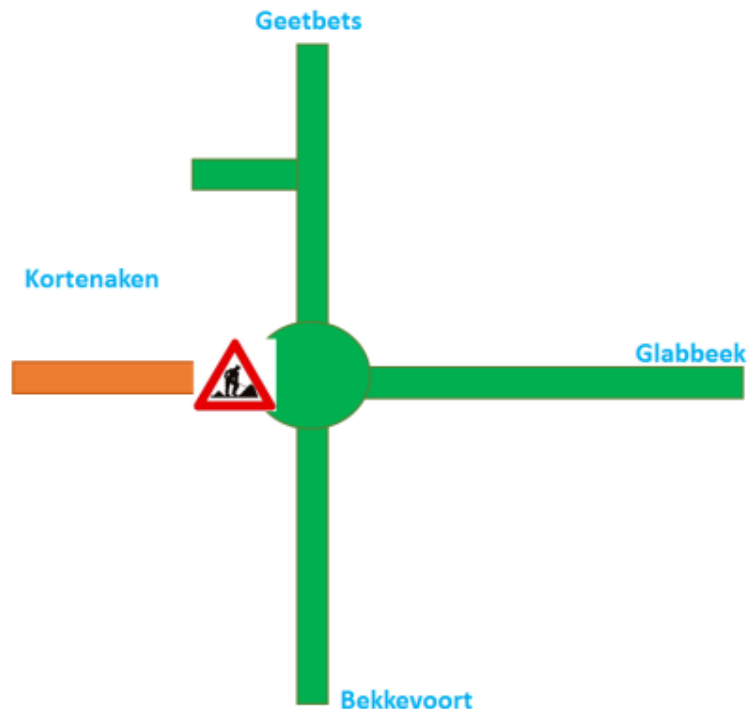
- Expert judgement
- Simulator
 - Fixed-based simulator
 - NADS MiniSimTM v2.0
- 7 experimental trips

Origin	Destination			
	South (Bekkevoort)	West (Kortenaken)	North (Geetbets)	East (Glabbeek)
South (Bekkevoort)	n/a	Route 1	Route 2	//
West (Kortenaken)	n/a	n/a	n/a	n/a
North (Geetbets)	Route 3	Route 4	n/a	Route 5
East (Glabbeek)	Route 6	Route 7	//	n/a

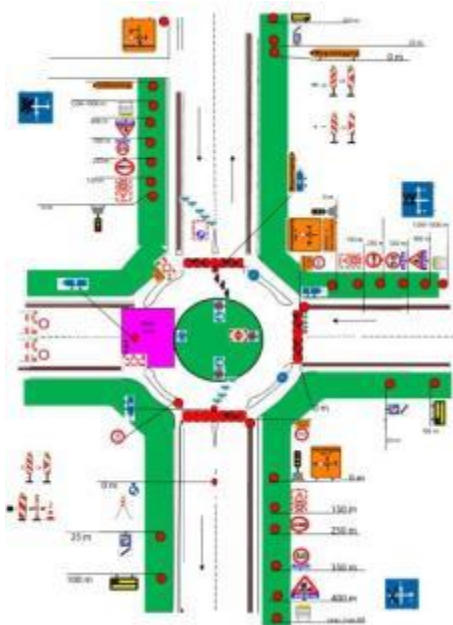
- Temporary signalization (the same for every branch)
 - Only during road works

Verkeersbord A33 + C43 op "raam"

Werfaankondiging

Verkeersbord C35

Verkeersbord C46 + F47

Verkeersbord A31 + onderbord 400m

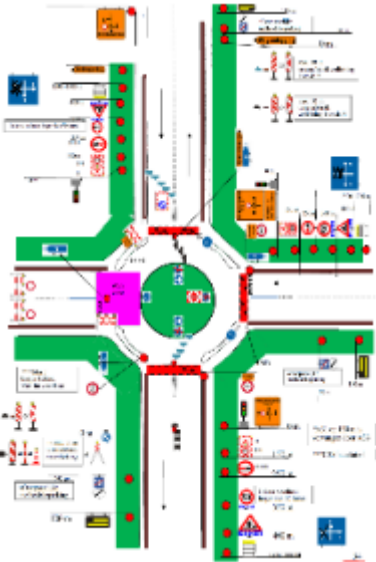
- Specific signalization
 - Always present
 - Advance direction sign (200 m before roundabout)
 - 1 direction is occluded

F25 op zuidelijke tak
(komende uit Bekkevoort)

F25 op oostelijke tak
(komende uit Glabbeek)

F25 op noordelijke tak
(komende uit Geetbets)

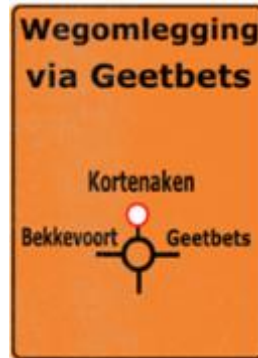
Route 6

- **Without roadworks:**
normal use of roundabout
= Counterclockwise
- **With roadworks:**
not normal use of roadworks
= Clockwise

- **77% incorrect** ($p < .0001$)
 - To the north
- Recommendation
 - Changing specific temporary signalization (clockwise) (2 possibilities)
 - Follow-up study (2017): 0 to 8% wrong

Verbal comment of 68% of incorrect (25/37): **not clear that roundabout is not complete** and **not clear to use it clockwise**
