Proceedings

Experimental and Numerical Analysis of Timber I-Joists with Cut-Outs ⁺

Rik Steensels * and Bram Vandoren

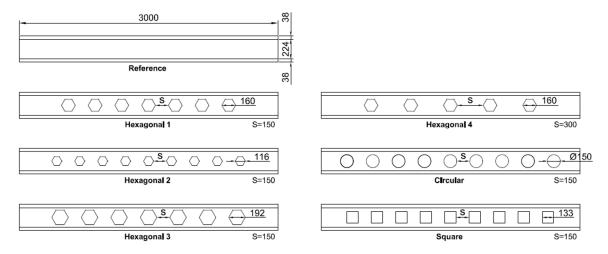
Figure 1. Overview of the geometries of the tested specimen, the applied cut-outs and spacing S.

A total of seven composite timber I joists are tested under three-point bending. Cut-outs of different size and spacing are introduced to six of these beams and one is kept without openings as a reference. The geometry of the specimens and an overview of the implemented cut-outs are presented in Figure 1. As can be seen, three different cut-out shapes, hexagonal, circular and square, are applied to the beams. An overview of the geometric properties including the cut-out spacing and surfaces are given in Table 1.

The total cut-out surface is varied along beams H1, H2 and H3 while the spacing and shape of the cut-outs is kept constant. Beam elements H1 and H4 share the same size cut-out geometry, yet the spacing is doubled. Finally, the influence of the shape of the cut-out can be analysed by comparing the experimental results of beams H1, CI and SQ since they have a similar area which has been eliminated at similar spacing. The load was applied using a manual hydraulic pump and the displacement in the centre of the beam was collected using LVDT's.

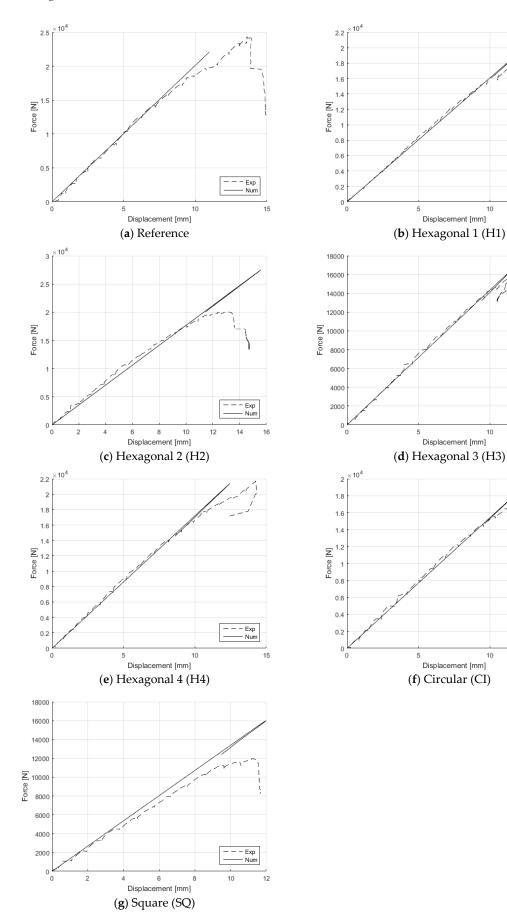
Figure 2. Experimental and numerical load-displacement diagrams of the experimentally tested beam elements.

The load-displacement diagrams of the beam elements are presented in Figure 2. From Figure 2a,d, it can be concluded that the ultimate load of the beam elements decreases as larger cut-outs are introduced. Unfortunately, it is not possible to directly compare the ultimate loads of these beams since different failure modes were identified during loading. The reference beam element without cut-outs and the H2 element showed failure due to lateral torsional buckling, while beams H1 and H3 failed due to excessive cracking of the web. This shift in failure modes has also been recognised by other authors [2,6,9].

Furthermore, it can be seen from Figure 2b,e that the spacing of the cut-outs affects the ultimate load of the beam elements. The ultimate load of beam H4 is about 10% higher than that of H1. However, the initial cracking and start of the nonlinear phase in the load-displacement diagrams take place at roughly the same point, more specifically at a loading of about 18 kN and vertical displacement of 1 cm.

Lastly, it can also be seen from Figure 2f,g that the shape of the cut-out severely influences the ultimate strength of the I-joist. This is mainly due to the stress concentrations in the corners of the square-shaped cut-out. These stress concentrations will initiate the timber fracture more quickly and will therefore also lower the overall strength of the beam element.

Overall, Figure 2 shows good agreement between the experimental and numerical data. Especially the initial stiffness and linear elastic behaviour of the beam elements is assessed well by the numerical model. The ultimate load is also in good agreement with the experimental value, except for the beams H2 and SQ, for which the numerical model overestimates the ultimate load (Figure 2c,g). For beam H2, this is associated with the failure mode which for this beam was due to lateral torsional buckling and not due to material failure of the hardboard web (geometric nonlinearities were not taken into account in the numerical model). Finally, Figure 3 depicts the failure mechanisms observed in the simulations, where it is noted that the asymmetric nature of these mechanisms (with the exception of beam H3) is caused by the asymmetric loading conditions of the beams: the exact, i.e., imperfect, roller positions of the experiments were also used in the simulations.

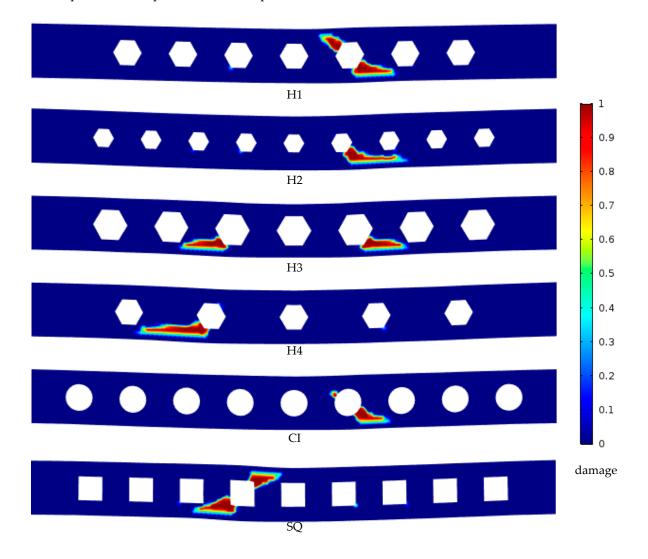
Figure 3. Numerical failure mechanisms of the beams.
