Faculteit Industriële ingenieurswetenschappen
master in de industriële wetenschappen: bouwkunde

Masterthesis

Shear reinforcement of longitudinal cracked glued laminated timber beams using carbon fibre reinforced polymers

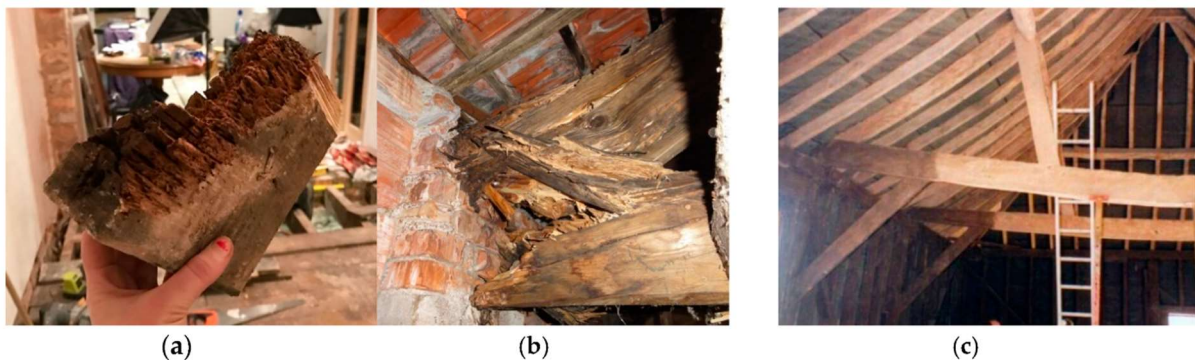
Figure 4 Examples of damage in timber structures: (a) and (b) show rotting wood at the beam ends and at the joists in the timber roof truss; (c) shows a deformed timber tie in a roof structure due to overloading [9].

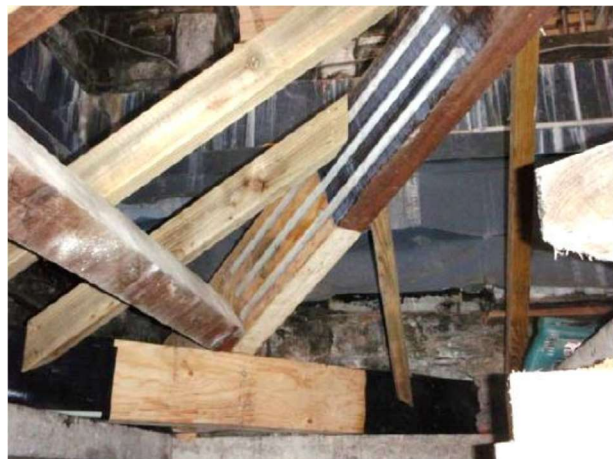
Figure 5 Repair of timber by replacing damaged timber [10]

Traditionally, timber structures were rehabilitated using timber or steel. When rehabilitating with timber, damaged pieces of timber were cut out of the beam and replaced with new pieces of timber or additional timber material was attached to the existing beam, creating a larger cross section that is stronger. [10] describes an example of replacing timber pieces, where part of a beam was rotten due to a failure in the roofs drainage system. The decayed timber was removed and replaced with a prosthesis made from laminated veneer lumber (LVL). The connection between the new and existing piece of timber was made by routing channels in the side of the beam, into which steel reinforcement was placed and bonded using a two-part epoxy adhesive. This solution can be seen in Figure 5.

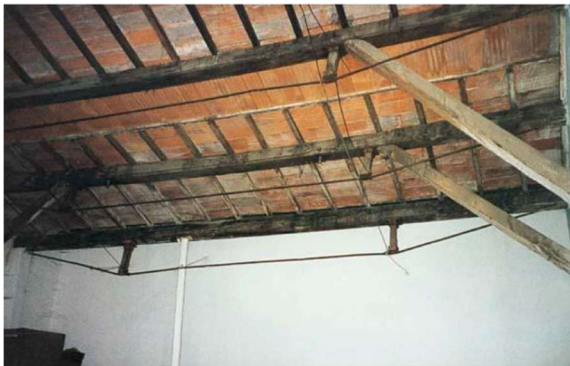
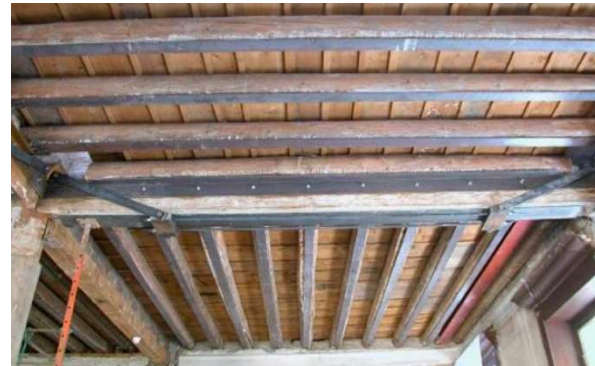
Figure 8 Strengthening of timber using steel by conversion into truss girder (left) and increasing cross section (right) [9]

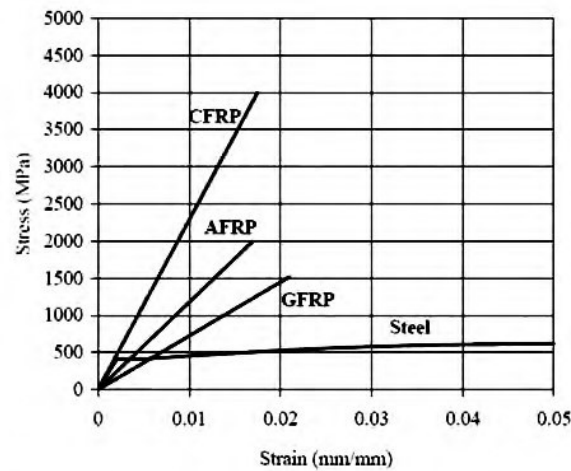
Figure 10 Stress-strain curve for steel and multiple FRPs [17]

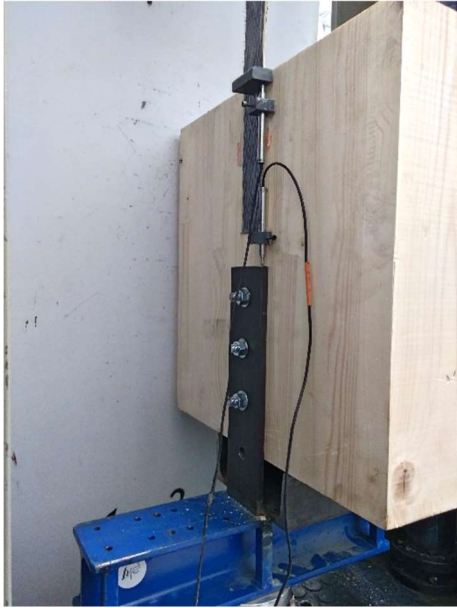
Figure 16 Placement of LVDTs during single lap shear tests

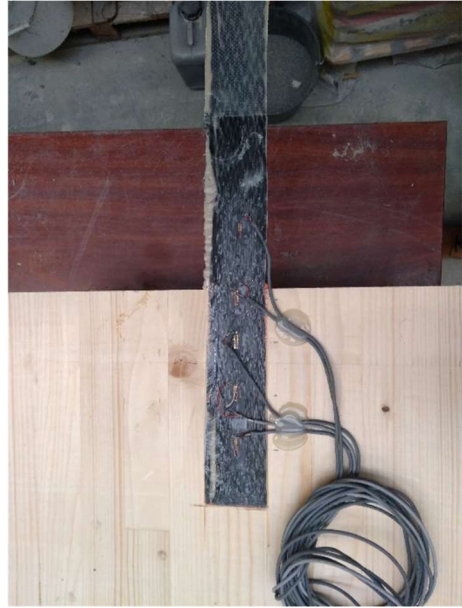
Figure 17 Placement of strain gauges during single lap shear tests

Strain gauges were applied to the surface of the CFRP reinforcement 50mm apart from each other. One of the strain gauges is placed outside the bonded area while the rest are placed in the bonded area, with the first of these strain gauges placed at the starting point of the bonding area. The strain gauges are placed throughout the reinforcement until the end is reached. In total, the test pieces with 200mm bond length have 5 strain gauges applied to them while the pieces with 250mm bond length have 6 strain gauges. Due to the high cost of these gauges, only a single test piece of each configuration has been tested with strain gauges. Displacement of the piece was also measured using 2 LVDTs or linear variable differential transformers. Both LVDTs are glued to the timber part of the test piece, with the first measuring the displacement between the timber and a block glued just outside the bonded zone of the CFRP. The second measures the displacement between the timber and the top of the steel bracket that holds the test piece in place. [Figure 16](#) shows a photo of the test set up. Measurements were taken with a frequency of 2 Hz (once every 0,5s). The load was applied by pulling the piece at a rate of 1mm every 60s.

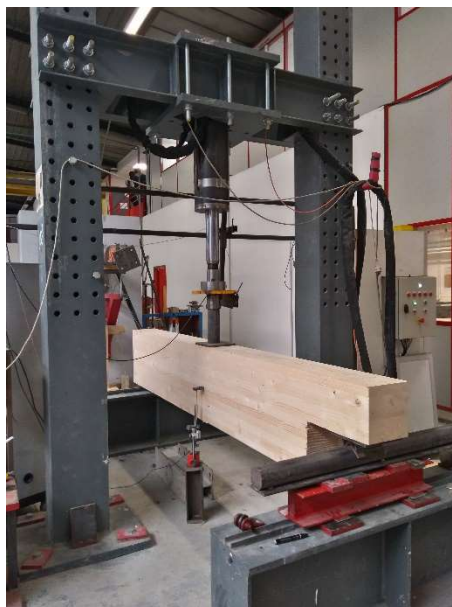
Figure 21 Testing configuration for 3-point bending tests

Deflection in the middle of the beam is measured using a laser distance meter, which takes measurements from a block glued to the side of the beam at the highest point of the beam. A LVDT will also measure the deflection of the middle of the beam, but instead with the block glued to the side of the beam at half the height. In the reinforced beam, strain in one of the CFRP reinforcement will also be registered using 6 strain gauges. These strain gauges are placed 50mm apart from each other with one placed on the level where the crack will be initiated, three above the crack and two below the crack. Measurements will be taken at a frequency of 2 Hz or twice every second. The beam was loaded by pushing down at the centre of the beam at a rate of 2mm every 60s.

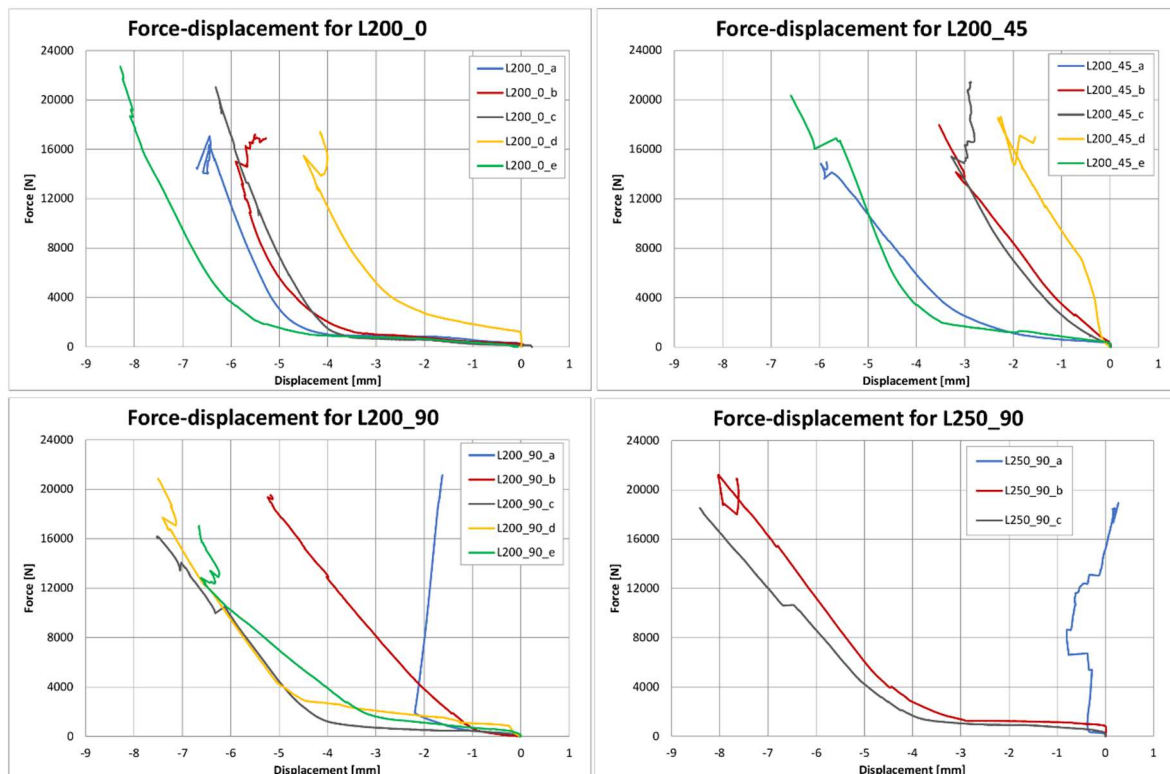
Figure 22 shows the force-displacement curves for all test pieces, ordered by the different test configurations. Results are shown until the maximum force is reached, to keep the graphs easy to read. Displacement for these results were obtained by taking the displacement from the LVDT on the CFRP and subtracting any displacement measured by the LVDT on the timber. This is done to ensure only the displacement of the CFRP reinforcement is measured and not introduce additional variance due to displacement of the timber. For a majority of the tested pieces, an initial phase where force grows slowly with the displacement can be observed. This is caused by the way the tests are set up. The test piece is secured with 3 bolts but in order to easily slide in the bolts and to account for any small deviations, the holes in the timber are drilled slightly larger than the bolt diameter. When tension initially gets applied, this small margin causes a displacement of the timber with low resistance.

Figure 22 Force-displacement graphs for all single lap shear tests

The strain gauges from test L200_0_a show us how the carried load can decrease slightly but not completely fail. When L200_0_a reaches 16 000 N of force, Figure 22 shows a sudden decrease in load carried by the test piece, while Figure 26 shows an increase in strain in sensor 2,3 and 4. This is most likely caused by local failure of the timber, which is confirmed by the cracking sound heard during testing, which reduces the bond surface area and thus the bond strength. However, since the piece doesn't fail at this point, the force is redistributed, increasing the strain in the carbon fibre reinforcement.

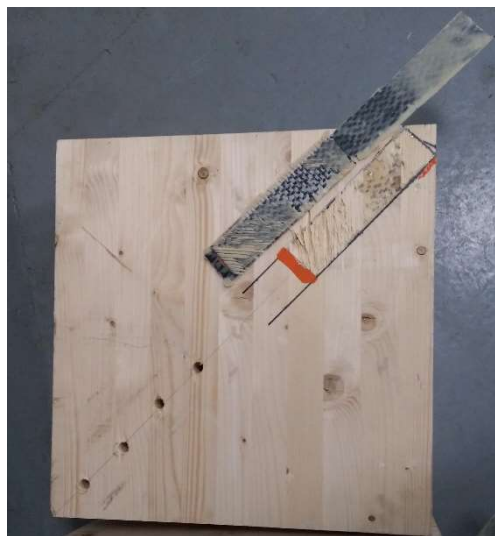
Figure 24 Bolt holes for L200_45 test pieces

The L200_45 series shows differences in force-displacement development compared to the other series, which produce similar results. The initial phase, where force grows slowly with displacement due to margins with the bolt holes, is much shorter or non-existent in this series. This is likely because these pieces were attached using 4 bolts, while the other test pieces only used 3, and the pieces were tilted 45° to achieve the required angle between the CFRP and the timber. This difference in bolt holes can be seen in Figure 24.

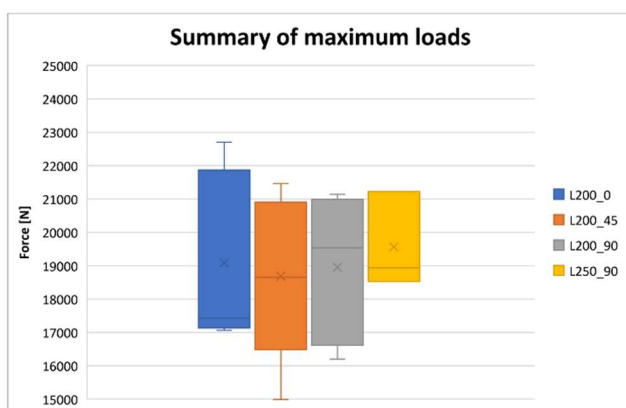
Figure 25 shows a summary of all the single lap shear tests performed, grouped by configuration. In general, there is no significant difference in bond strength between the different configurations, with less than a 5% difference between the highest and lowest average. The configuration L250_90 does show smaller spread than the other configurations, but this is most likely a result of the lower amount of test pieces for this configuration than the others and the difference is not significant enough to conclude that a bond length of 250mm decreases the variability in bond strength.

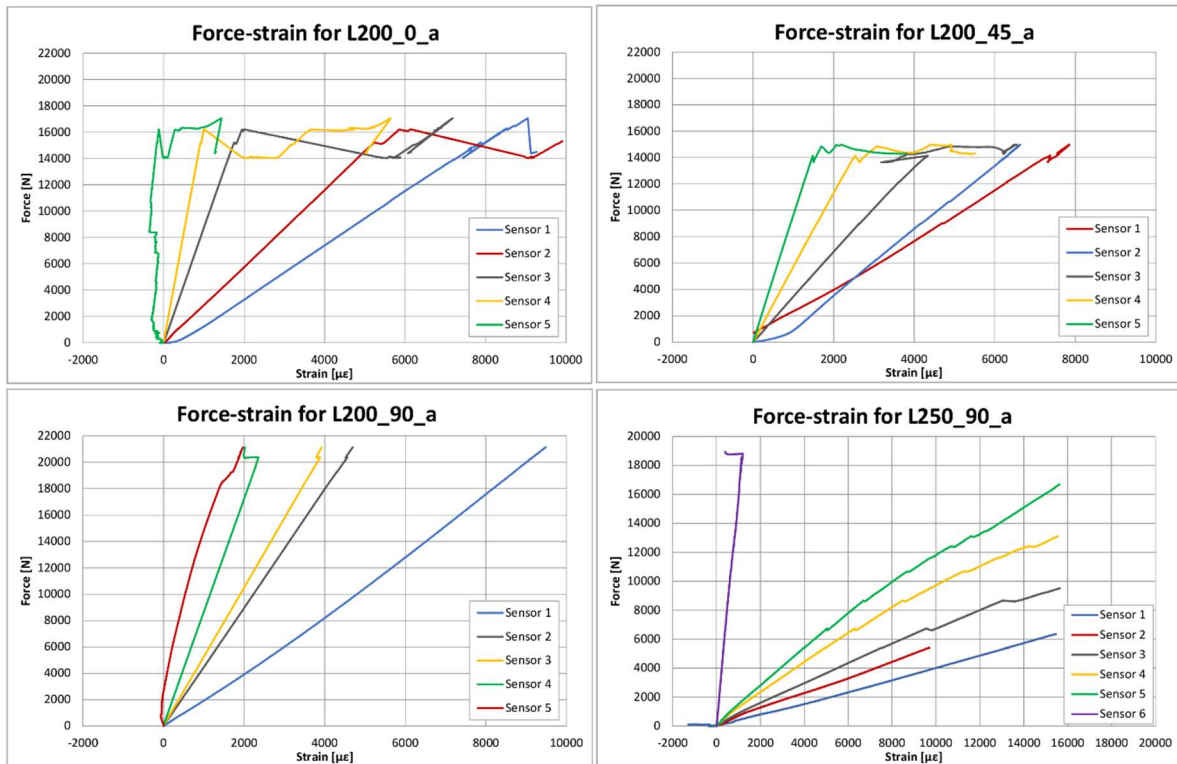
Figure 26 Strain gauge measurements during loading

Unfortunately, failure in L250_90_a was different from the others, as seen in the graph for the strain gauges in Figure 26. Strain grew much faster for this test piece and each of the strain gauges fails one by one, all at a different load. Strain gauge 2 also experienced a huge drop around 5 500 N because of an error with this sensor, so results from this sensor were cut off at this point. The strain development for L250_90_a suggests that the debonding process was gradual instead of sudden, like the other tested configurations with strain gauges applied. This means that it is impossible to verify whether effective bond length was reached using the strain gauges. However, maximum force reached by the new configuration didn't show a noticeable increase, allowing us that the effective bond length was reached within 200 mm.

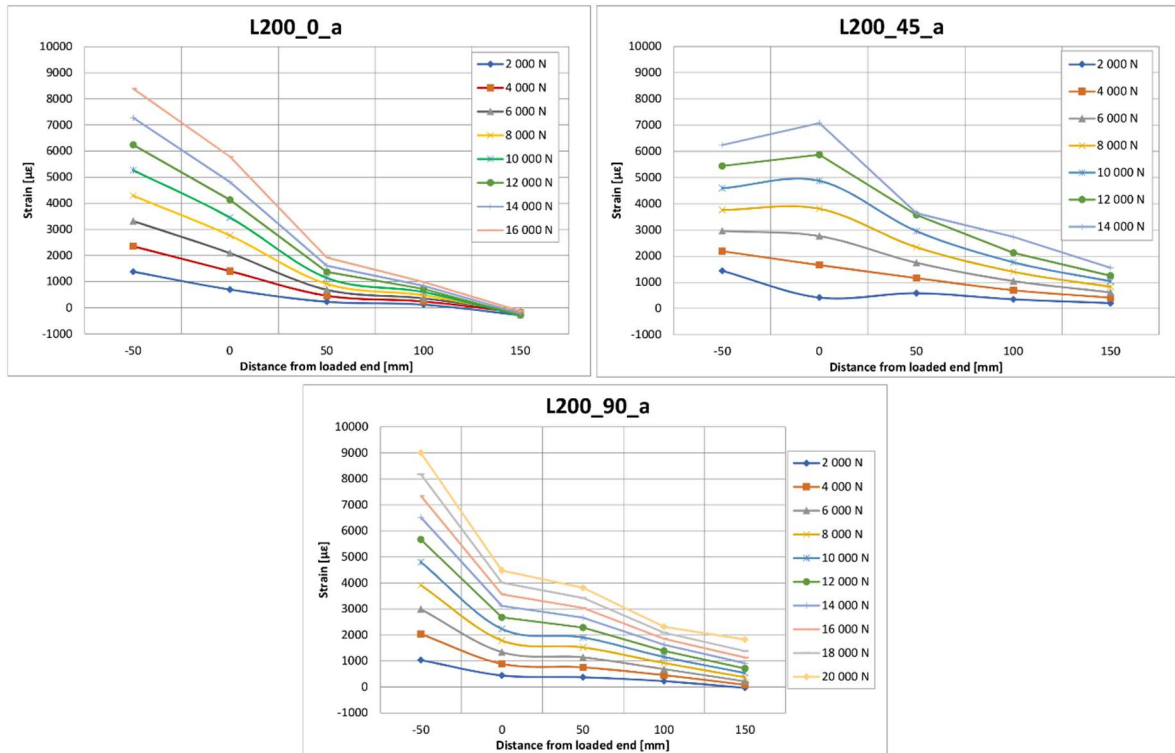
Figure 27 Strain in every sensor at different loads

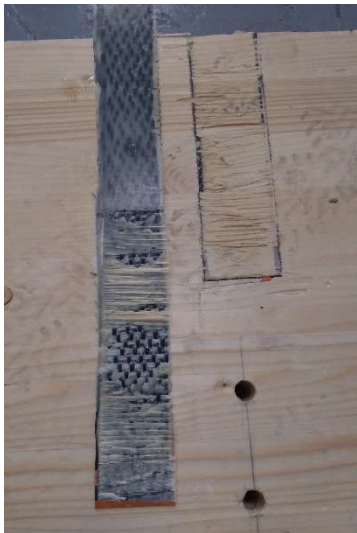
Figure 29 L200_45_d shows a typical failure mode, with a combination of failure in resin and timber surface

During testing, failure modes were also registered and photographed. There were no significant differences between the different configurations, with no noticeable correlation between failure mode and configuration. 16 out of the 18 test pieces showed similar failure modes, with failure in the surface of the timber, in the resin or a combination of both. L200_45_c was an exception, with a small chunk of timber coming off together with the reinforcement, as shown in Figure 30. This can be explained by the high load of 20 350 N this piece resisted before failure and limited restriction of the piece of timber due to being at the point where 2 edges meet. L200_0_c also showed unique behaviour, although this was caused by the test setup instead of the materials. After around 660s, some torsion in the reinforcement was visible, which lead to partial failure in the unbonded zone of the reinforcement at around 720s and eventual full failure. This explains why its load development graph in Figure 22 looks different from the others, with a drop to 9 000 N without complete failure. The load at which this piece failed is within the range of the others, but it still failed before debonding and thus is not fully representative of the debonding strength.

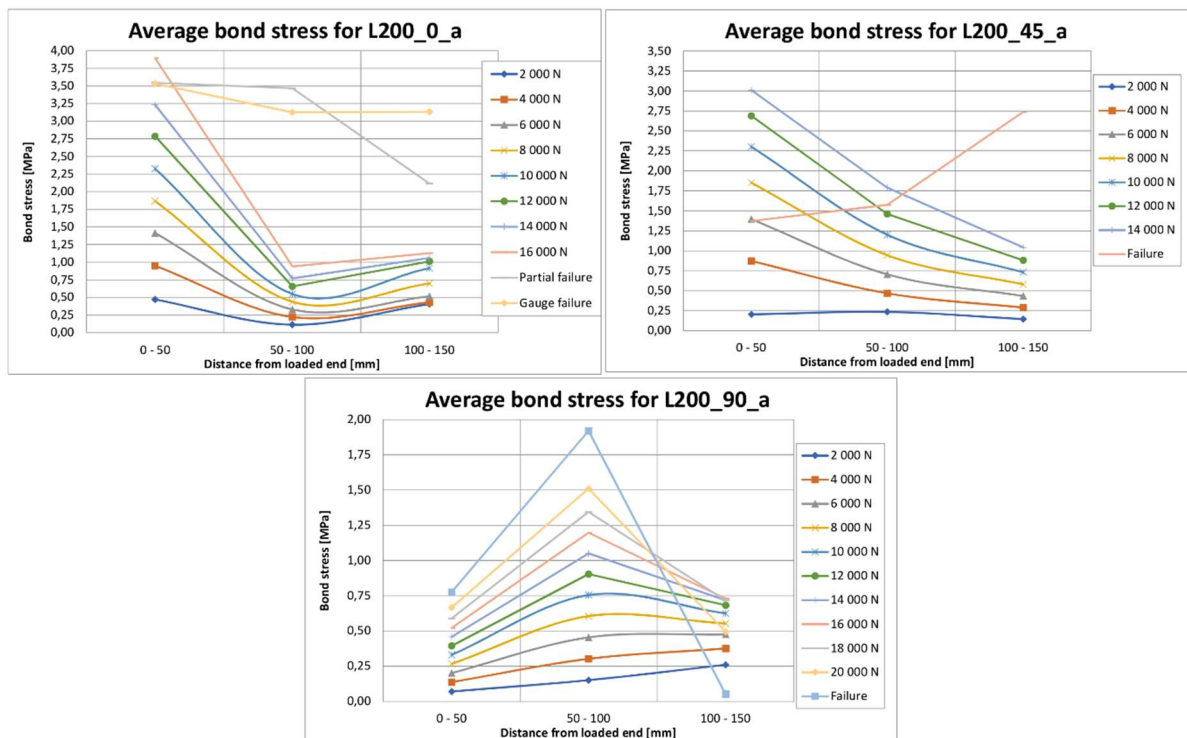
Figure 31 Average bond strength between 2 strain gauges

General behaviour is very similar for all 3 specimens, as shown in Figure 31: bond stress grows consistently in all the zones, until partial failure occurs in one of the zones, which can be identified by a sudden drop in bond stress. At the same time, bond stress sees an increase in one or both of the other zones. However, there are some notable differences between the different test pieces. L200_45_a shows the general behaviour the clearest: bond stress grows evenly, with the highest value in the first zone and the lowest in the last zone. This stress grows consistently until the bond start to fail between 0 and 50 mm, at which point the stresses are redistributed to the other zones. This redistribution of stresses only occurs close to failure, suggesting that the piece is unable to redistribute the stresses successfully.

Bond stress for L200_0_a is much less evenly distributed before partial failure, with the zone between 0 and 50 mm reaching the highest value out of all calculated zones. Once the bond partially fails in the first zone, bond stress drops but only by 0,348 MPa, which is much lower than in the other cases. At the same time, bond stress grows more rapidly in the other zones. The most likely explanation for these results is that the resolution is not high enough, resulting in results from the strain gauges that are not representative for the entire zone. Timber is a heterogenous material and higher strength of the material close to the strain gauge could have resulted in higher bond strength in this location. This is further confirmed by the failure force, which is not significantly higher than the other tested pieces.

Finally, bond stress for L200_90_a also gives us additional insight in the bond stress evolution. While the general evolution is as expected, the position at which highest stresses are measured and partial debonding occurs are different. Bond stress is highest in the middle rather than the start of the bonded length and partial failure doesn't occur in the zone with the highest bond stress. This could be caused by lower strength locally in the timber, in the bond or minor variance in the test setup, but the above average maximum force achieved by this piece suggest that this didn't negatively impact final bond strength.

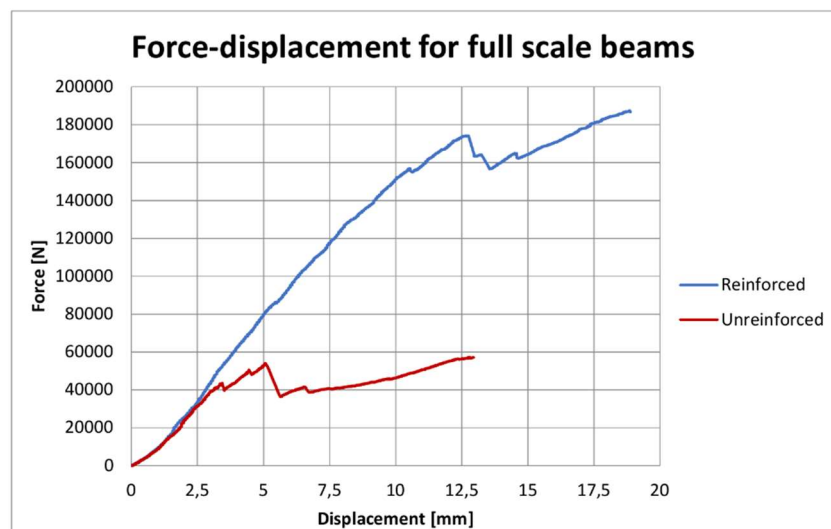
To compare the load carrying capacity of the unreinforced and reinforced beams, a force-displacement graph was created, as shown in Figure 32. The displacement used for this graph was taken from the laser measurements and the graphs were cut off once maximum force was reached. Both graphs develop similarly, with an initial phase of nearly linear development of force over time until a small drop is measured, after which the force develops more slowly until the eventual failure. This drop was combined with the visible and audible development of the shear crack during testing. However, the forces at which these events occur are vastly different, with the reinforced beam needing nearly 4 times the force before the first crack starts to develop (156 688 N vs 40 813 N). Failure strength is also much higher in the reinforced beam at 187 438 N compared to the unreinforced beam, which failed at 57 250 N.

Figure 32 Force-displacement curves for the reinforced and unreinforced beam

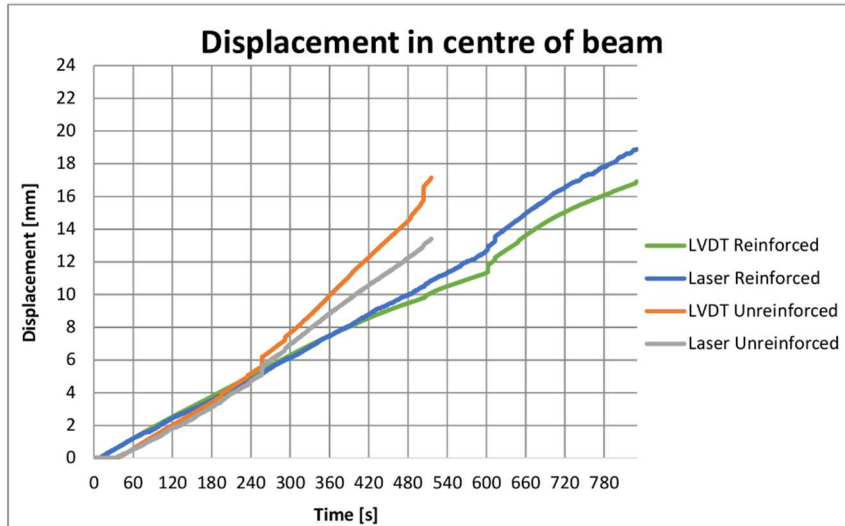
Displacement in the centre of the beam is very similar when both beams haven't cracked, as shown in Figure 33. Once the initial crack is developed, the beams start displacing at a faster rate. The biggest difference between both beams is once again the moment at which the beam cracks and thus when the deflection increases at a higher rate. The final deflection, measured by the LVDT in the middle of the cross section, before failure is very similar, with the LVDT measuring 17,196mm in the unreinforced beam and 16,193mm in the reinforced beam. The laser measurements showed a difference, with 13,405mm and 18,88mm respectively for the unreinforced and reinforced beam respectively.

Figure 33 Displacement measured in the centre of the beams

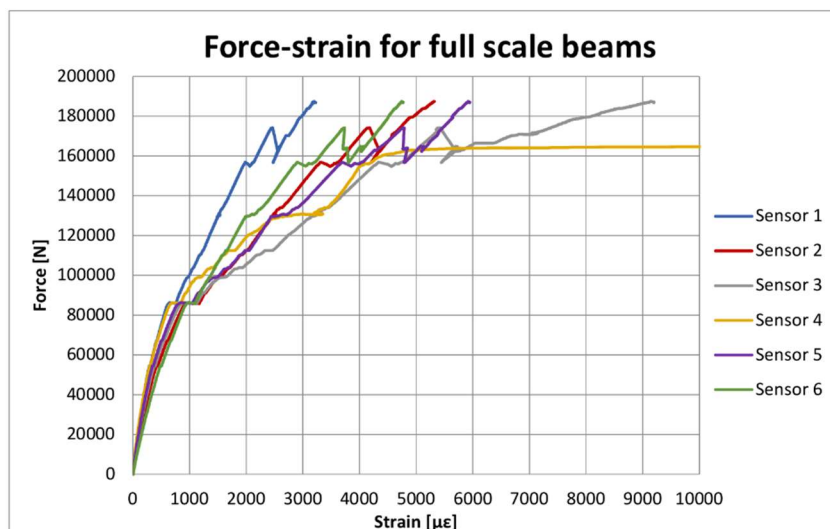
Next, the strain in the different strain gauges is shown over time in Figure 34, where more insight is gained in how the stresses develop during loading. An initial phase where strain in the reinforcement develops slowly can be seen between 0 and 260s, after which strain develops at a higher rate. This is also the period that the unreinforced beam needed to develop its first crack. This gives reason to believe that in this initial phase, the shear force is distributed between the reinforcement and the timber, while after this phase the shear force is carried solely by the reinforcement. These claims are further substantiated by the fact that small drops in load carrying capacity show sudden increases in strain in the reinforcement.

Figure 34 Strain gauge measurements during loading of the reinforced beam

Gauge 4 behaves differently than the others, as it reached a value of 15 859 $\mu\epsilon$ before failing at a force of 164 938 N, and needs further explanation. This gauge is applied to the reinforcement directly over the shear crack that is initiated. Although a small part of the sudden changes can be explained by crack development in the timber, it doesn't explain why it behaves so differently to the other gauges. However, when observing the test piece during loading, the fibres in this part of the reinforcement showed some horizontal movement. This is most likely why strain gauge 4 failed prematurely while the reinforcement did not.

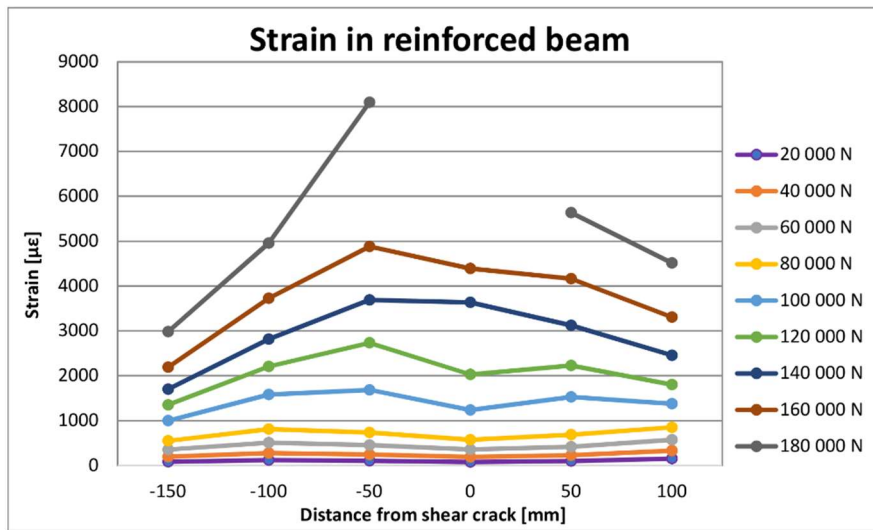
Just like for the single lap shear tests, the strain is plotted for the different locations at different load levels in Figure 35. Similar strain evolution can be seen as during the single lap shear tests, suggesting that the reinforcement for the full-scale beam failed in a similar matter.

Figure 35 Strain in different strain gauges at different loads for full scale beams

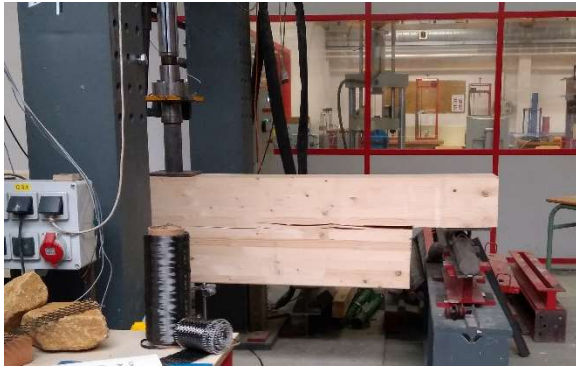
Figure 36 Shear crack after failure of the unreinforced beam

Failure modes for both beams were also identified during testing. Both beams developed the shear crack as expected at the end of the cut out, although there was a significant difference in crack width. The crack was noticeably smaller for the unreinforced beam (as shown in Figure 36 and Figure 37), although this is most likely due to the much larger force being released at failure for the reinforced beam. This is further confirmed by the louder noise created by the failure of the reinforced beam. The bond surface was also inspected after failure and showed similar debonding patterns as during the single lap shear tests, confirming that the beam did indeed fail due to debonding and not another, unexpected failure mode. Figure 38 shows what the surface of the reinforcement looked like after failure.

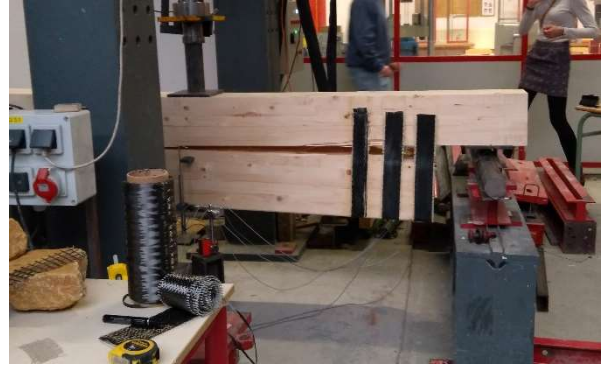
Figure 37 Shear crack after failure of the reinforced beam

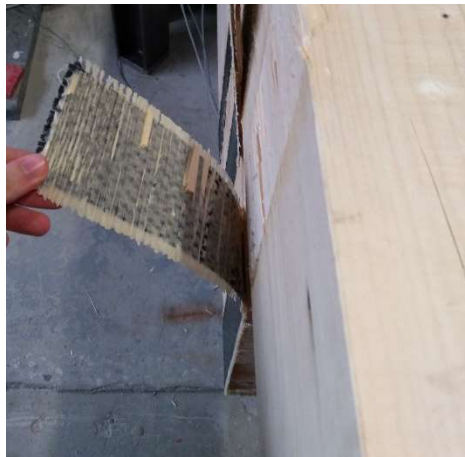
Figure 38 Surface of debonded reinforcement after failure
