Experimental Investigation of Dapped Ends with Diagonal Reinforcement

EXPERIMENTAL INVESTIGATION OF DAPPED ENDS WITH DIAGONAL REINFORCEMENT

by Chathura Rajapakse, Hervé Degée and Boyan Mihaylov

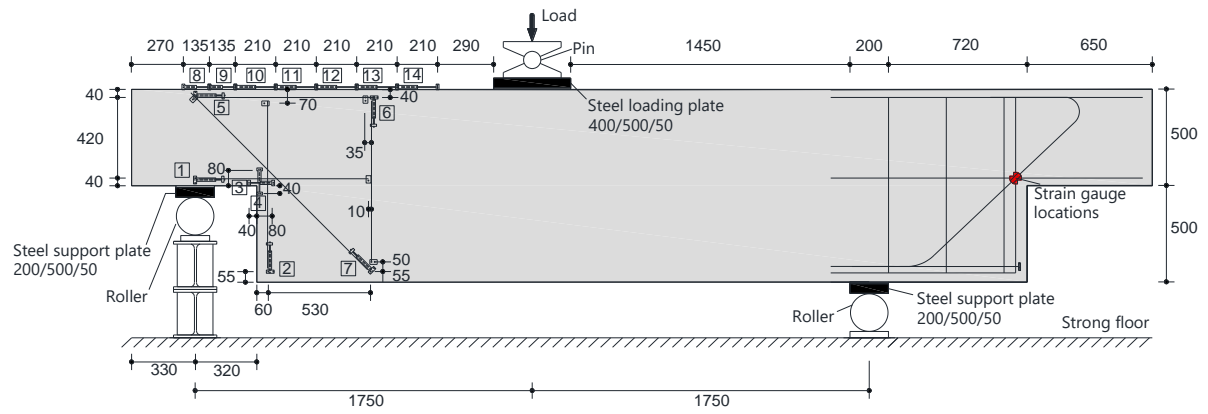
Fig. 3 – Test setup and instrumentation (dimensions in mm)

The test setup used for the experimental campaign is presented in Figure 3. The beams were subjected to three-point bending such that only one of the two dapped-ends was tested at a time.

8 The instrumentation of the testing dapped end consisted of a series of displacement transducers
9 (DT) and strain gauges – see Figure 3. The displacement transducers were mounted on the
10 surface of the specimens at strategic locations to provide continuous measurements of both
11 local and global deformations of the connections. DT 1 and 2 were placed along the main
12 horizontal and vertical reinforcement near the re-entrant corner, while DT 5, 6 and 7 were
13 arranged in a triangle to provide a global measure of the deformations in the connection. The
14 horizontal and vertical components of the corner crack displacement were measured by DT3
15 and DT4, respectively. DT 1-7 were applied to one side face of each connection. The
16 compressive deformations of the top concrete fibers were measured by DT 8-14, which were
17 arranged in a chain on the top face of the beam.

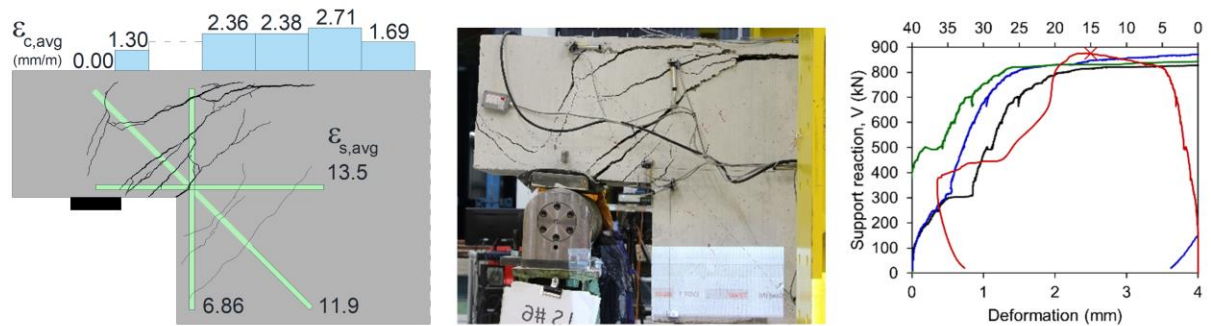
(f) Beam 3-DL6: left – crack pattern near peak load (875 kN), middle – after failure, right – support reaction vs. crack components at the re-entrant corner

The two connections of beam 3, 3-DL5 and 3-DL6, exhibited a qualitatively similar cracking behavior to beam 2, until near peak resistance. The failure of the weaker end, 3-DL5, occurred with separation of the top concrete cover above the tip of the re-entrant corner crack. The failure of the stronger end, 3-DL6, occurred due to rapid opening of the inclined crack propagating from the inner edge of the support in the dapped end. This was also accompanied by the separation of the top concrete cover.

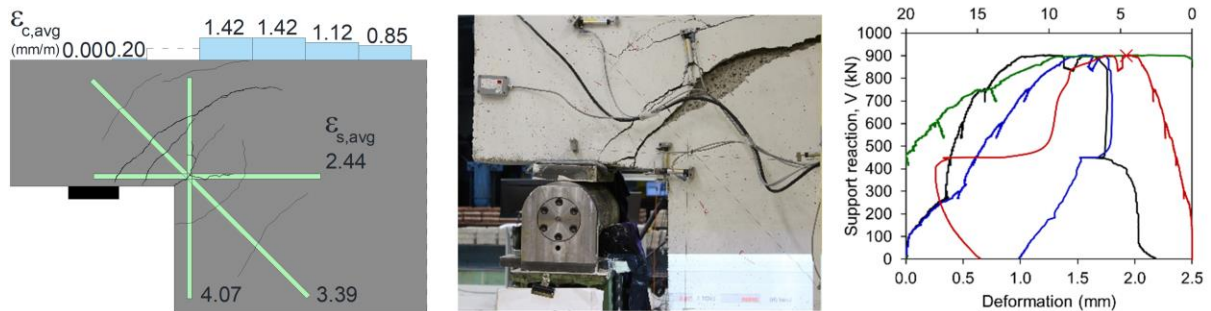
(g) Beam 4-DL7: left – crack pattern near peak load (900 kN), middle – after failure, right – support reaction vs. crack components at the re-entrant corner

In the two connections that featured the heaviest amount of reinforcement, 4-DL7 and 4-DL8, the corner crack was relatively small near peak load, with crack displacements in the range of 1 to 2 mm. The inclined shear cracks in the dapped end were visibly wider than the corner crack – see Figs. 4g (left) and 4h (left). The failure of the two connections was much more brittle relative to the other specimens of the test series, as can be seen from the load-deformation plots in Figures 4 and 5. The photograph of specimen 4-DL7 in Figure 4g (middle) shows that the failure occurred in shear due to diagonal crushing of concrete. The crushing occurred between the two inclined cracks in the dapped end, in the region intersected by the main layers of vertical reinforcement. Specimen 4-DL8 also failed in shear by rapid opening of the inclined crack propagating from the edge of the support plate. However, it is important to note that these shear failures occurred after (or near) yielding of the main dapped-end reinforcement.

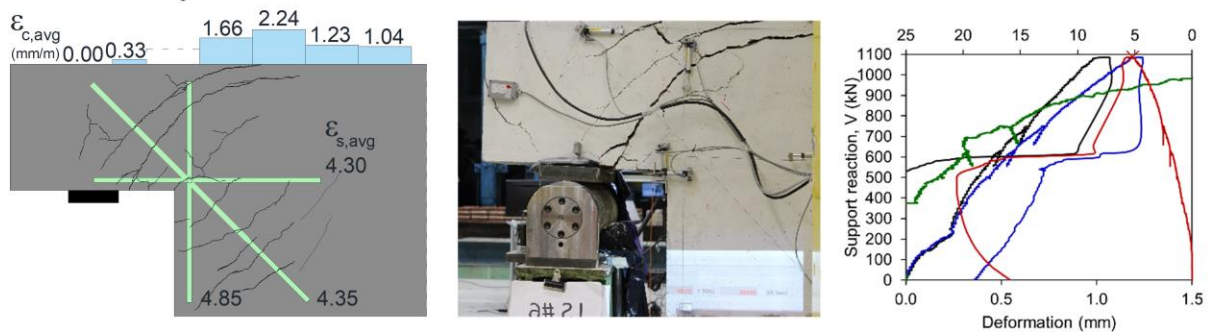
(h) Beam 4-DL8: left – crack pattern near peak load (1088 kN), middle – after failure, right – support reaction vs. crack components at the re-entrant corner

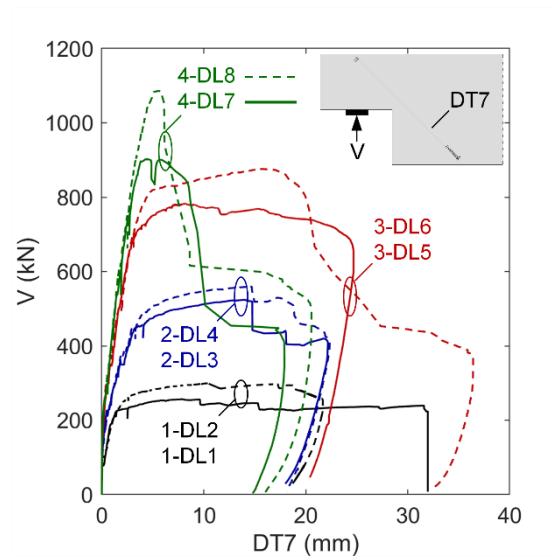
Fig. 5 – Strength and ductility of the test specimens

1 approximately 4-fold from 257 kN to 903 kN. This disproportionality is largely due to the
2 change of failure mode observed in the test specimens. The lightly reinforced specimens such
3 as 1-DL1 and 1-DL2 failed along a dominant re-entrant corner crack. As the reinforcement
4 amount was increased, the corner crack was comparatively smaller at ultimate conditions, and
5 the failure mode shifted to shear failures along inclined cracks in the dapped-end region.
6 Consequently, the ductility of the heavily reinforced connections was reduced, in contrast to
7 the lightly reinforced specimens. This global trend is illustrated in Figure 5, where the
8 variations of support shear load with the diagonal elongation (DT7) are plotted. It can also be
9 seen that, of the two dapped ends of each beam, the more heavily reinforced connection (dotted
10 lines) generally showed slightly less ductility.

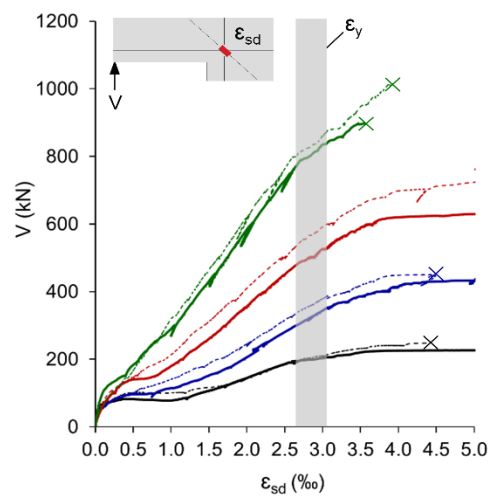
(a) Dapped-end horizontal reinforcement (X mark indicates strain gauge malfunction)

(b) First layer of dapped-end vertical reinforcement

(c) Diagonal reinforcement

Fig. 6 – Measured strains of main dapped-end reinforcement

Figure 6 shows the measurements of the strain gauges attached to the main horizontal, vertical, and diagonal reinforcement. It can be seen that the reinforcement in all connections exhibited significant plastic deformations before failure. As these tests featured no stirrups in the clear shear span, and a considerable amount of reinforcement in the dapped end, this indicates that these connections are more prone to failure along a re-entrant corner crack.

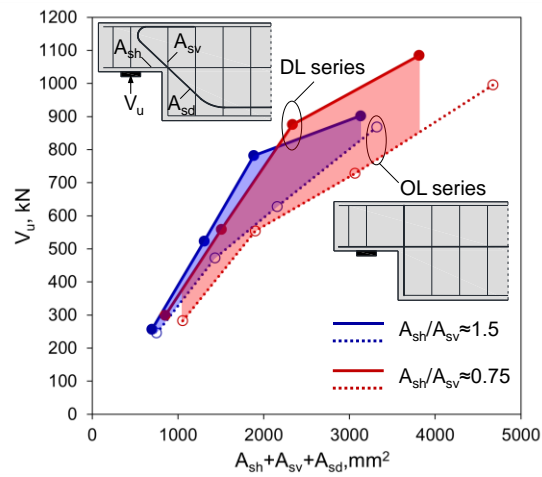
Fig. 7 – Effect of total amount of dapped-end reinforcement on the measured strength

Figure 7 illustrates the effect of total amount of dapped-end reinforcement $A_{sh}+A_{sv}+A_{sd}$ on the measured ultimate strength V_u of the DL and OL specimens. The DL series is plotted in continuous lines with filled markers, while the OL specimens are shown as empty markers connected with dotted lines. The plot further distinguishes between the connections with different horizontal-to-vertical reinforcement ratio A_{sh}/A_{sv} , where $A_{sh}/A_{sv}\approx 1.5$ and $A_{sh}/A_{sv}\approx 0.75$ are denoted by blue and red color, respectively. It can be seen that the increase of strength with increasing amounts of reinforcement was nonlinear for both the DL and OL series, where the rate of increase decreased in the more heavily reinforced specimens. This occurred largely in

More importantly, the difference in strength of the DL and OL specimens are shown by the blue and red shading in Figure 7. It can be seen that, for the same cross-sectional area of reinforcement, the specimens with diagonal reinforcement layouts were considerably stronger than connections with only orthogonal reinforcement in the dapped end. A larger strength increase can be observed in the specimens with $A_{sh}/A_{sv}\approx 0.75$ (red color shading). For this configuration, the strength increase was approximately 30% for the smallest and largest values of $A_{sh}+A_{sv}+A_{sd}$. The largest strength increase of ~40% was observed in specimen 3-DL6, which had an intermediate amount of reinforcement area $A_{sh}+A_{sv}+A_{sd}$. This shows that the provision of an alternate load path by the addition of diagonal reinforcement has a significant beneficial impact on the strength of dapped-end connections. However, it must be noted that this increase in strength can only occur if enough displacement capacity is available to simultaneously develop the different strength mechanisms.

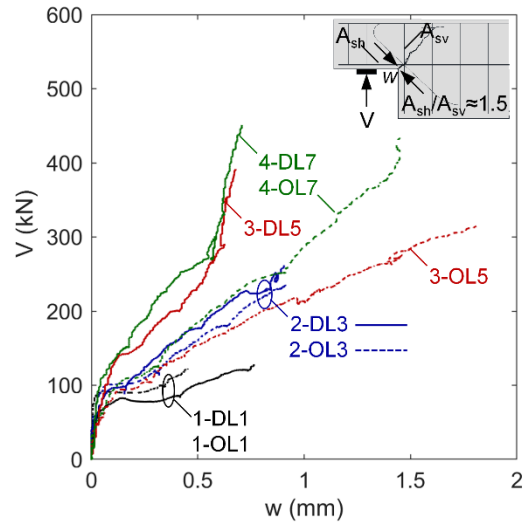
(a) $A_{sh}/A_{sv} \approx 1.5$ configuration

(b) $A_{sh}/A_{sv} \approx 0.75$ configuration

Fig. 9 – Crack widths at the re-entrant corner under service loads (for $V \leq V_u$)

A closer look at crack control under service loads is shown in Figure 9, where the corner crack widths corresponding to a support shear load of up to 50% of the peak resistance ($V\leq 0.5V_u$) are plotted. It can be seen that all test specimens from both the DL and OL series displayed excessively wide crack widths under service loads. While the addition of diagonal reinforcement enhanced the crack control, the crack widths were still larger than typical code
