Masterthesis

Out-of-plane two-way bending shaking table tests on gable walls

This experimental attempt aims to address the existing knowledge gap by conducting dynamic testing on three full-scale gables consisting out of replicated historic masonry. Each full-scale specimen consists of an out-of-plane (OOP) panel with same conditions but applied with different loads at the top table and same loads at the bottom table. The various loads at the top table simulate the different roof configurations of stiff, semi-flexible and flexible case that the gable could support. These specimens were subjected to incremental input motions until collapse occurred.

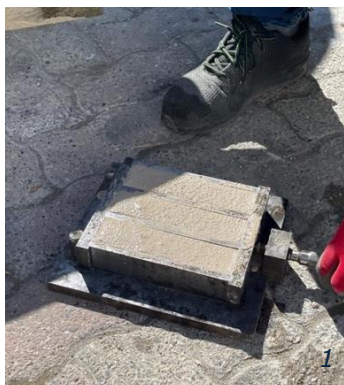
The mortar specimens are dimensioned by 160x40x40 mm corresponding to the dimensions of the mould, used to cast the samples as shown in Figure 1. These specimens have had a drying period of 2-3 days in the mould until they could be demoulded, as illustrated in Figure 2 and Figure 3.

Figure 1 : Making the specimens in the mould

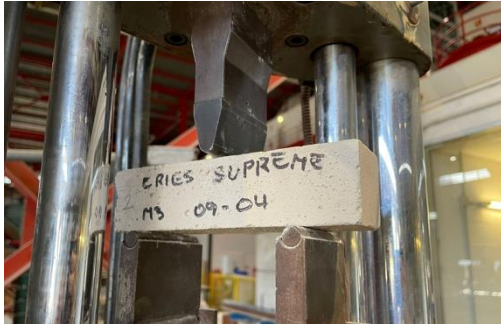
The compressive machine is operated with a constant loading rate, falling of between 50-100 N/s, ensuring that failure occurs within the timeframe of 30 to 90 seconds. The flexural test resulted in two fractured parts of the mortar parallelepiped, illustrated in figure 5 [6].

Figure 4 : Test setup determination of flexural strength

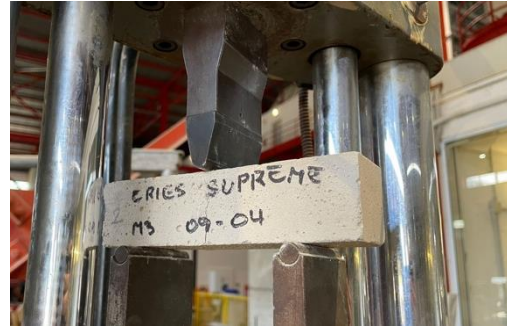
Figure 5 : Failure crack of the mortar

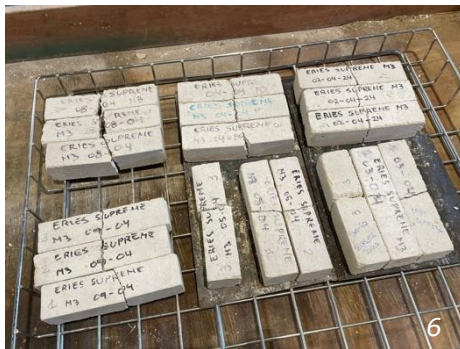
Compressive strength is the most critical mechanical property of mortar, given that masonry structures are predominantly subjected to compressive loads. The assessment of compressive strength is conducted immediately following the flexural test, the mortar specimens were split in half allowing both sides to be utilized resulting in 6 samples per mould show, by applying a load until failure. Subsequently, an increasing force is gradually and smoothly applied to induce failure of the specimen, these specimens are illustrated in Figure 6.

Figure 6 : compressive strength specimens after testing flexural strength

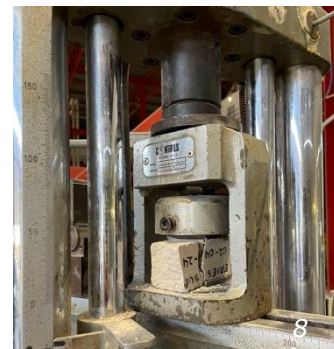
Figure 8 : Failure mortar under compressive strength

speed is set to 0.4 kN/s, gradually increasing the applied force until failure represented in Figure 8, while avoiding any sudden shocks [6].

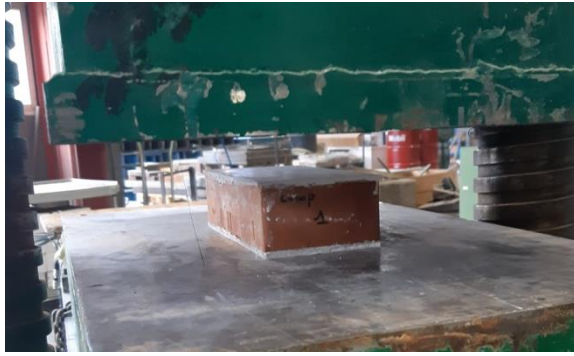
The compressive strength of the bricks used was evaluated according to the guidelines of EN 772-1(2011) [2]. The bricks were positioned with the surface of 105x230 mm on the compression machine's plate to compute the strength in the direction of the weak axis, shown in Figure 9. The load was gradually increased from zero until the brick failed, as shown in Figure 10. To compute the compressive strength, six samples were tested to gain an overall view, these are shown in figure 11. [6]

Figure 9 : Test setup of compressive strength of unit

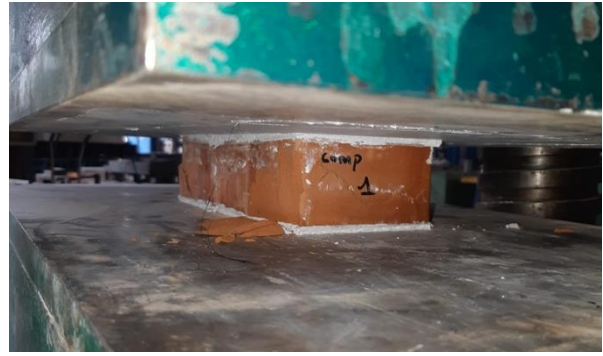
Figure 10 : Failure of the unit

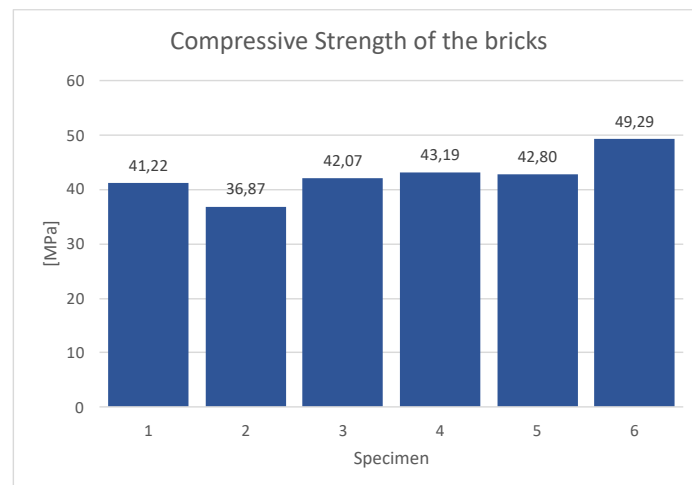
The mean compressive strengths of the bricks utilized are summarized in Table 3. These values reflect the uniformity and quality of the bricks produced. A high coefficient of variation (C.o.V) in compressive strength may indicate potential deficiencies in the material. The results also demonstrate that the bricks meet the specified design requirements, as outlined in the technical specifications.

Figure 11 : Distribution of compressive strength of the brick units

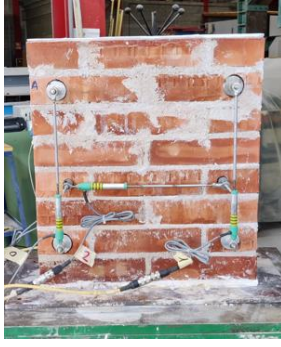
Figure 13 :
Instrumented wall,
front side

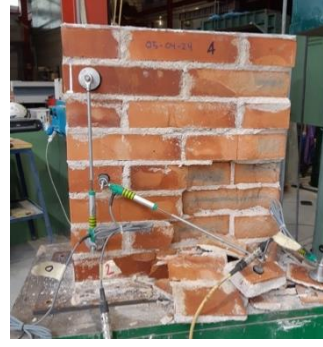
Figure 15 : Failure wall
after compression,
front side

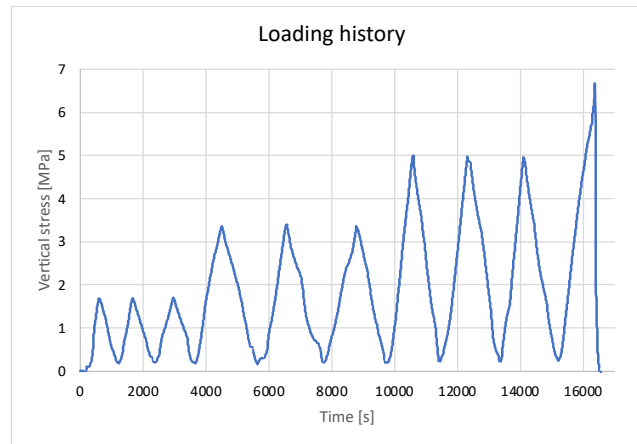
The loading cycle, as seen on Figure 17, performed manually, adhering to the velocity parameters specified in EN 1052-1(1998) [7]. This procedure resulted in an approximate test duration of around two hours for each wallette. The calculation of the elastic modulus of masonry in addition to determining its compressive strength was derived.

Figure 17 : Loading history, vertical stress vs. time, for compression testing of the wallettes

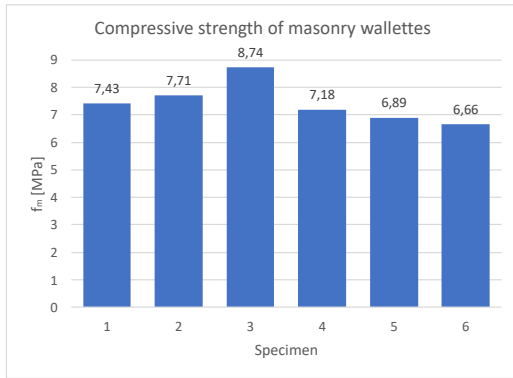
Table 4. Vertical and horizontal deformations/strains were computed by averaging the deformations/strains recorded by each vertical and horizontal potentiometer in the same directions. It is worth noting that E_1 is calculated as the secant elastic modulus between 10% and 33% of f_m and the origin (0;0) from a graph depicting vertical stress and vertical strain. The distribution of compressive strengths and secant modulus can be observed in figure 18, figure 19, figure 20 and figure 21 respectively.

Figure 18 : Compressive strength of masonry wallettes

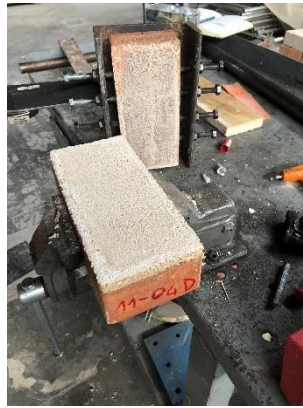
Figure 23 : Failure of the bed joint 1

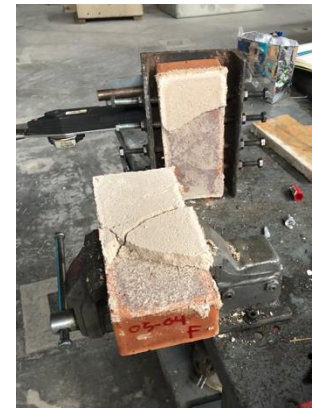
Figure 24 : Failure of the bed joint 2

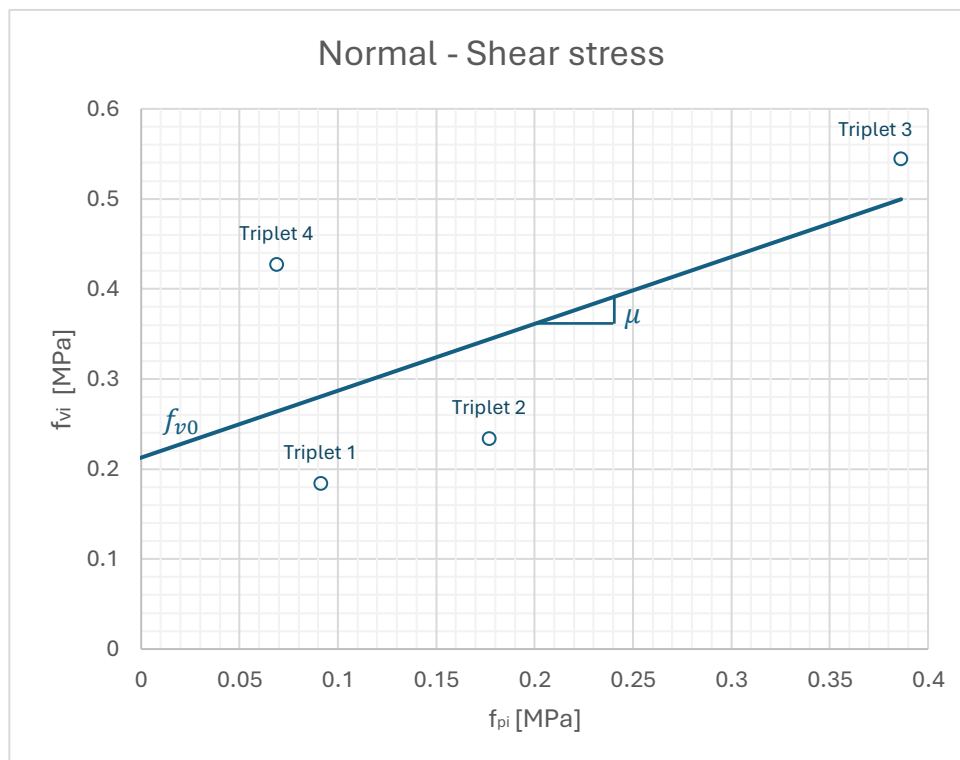
Figure 29 : Coulomb's friction law representation of results of the triplets in direct shear

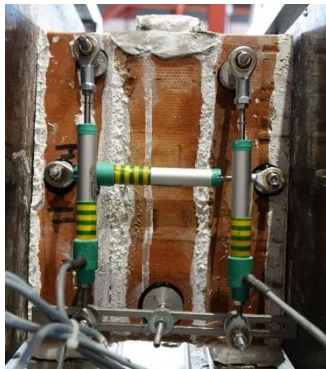
Figure 34 : triplet 2 in test set-up and after failure

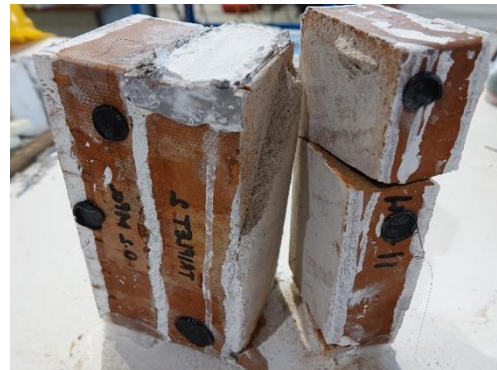
Figure 35 : fully formed crack after testing the shear strength

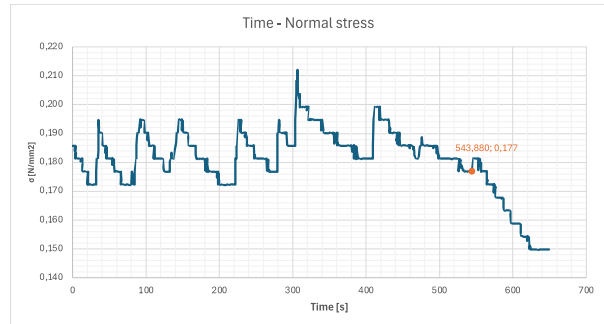
Figure 41 : Time - normal stress relation - Triplet 2

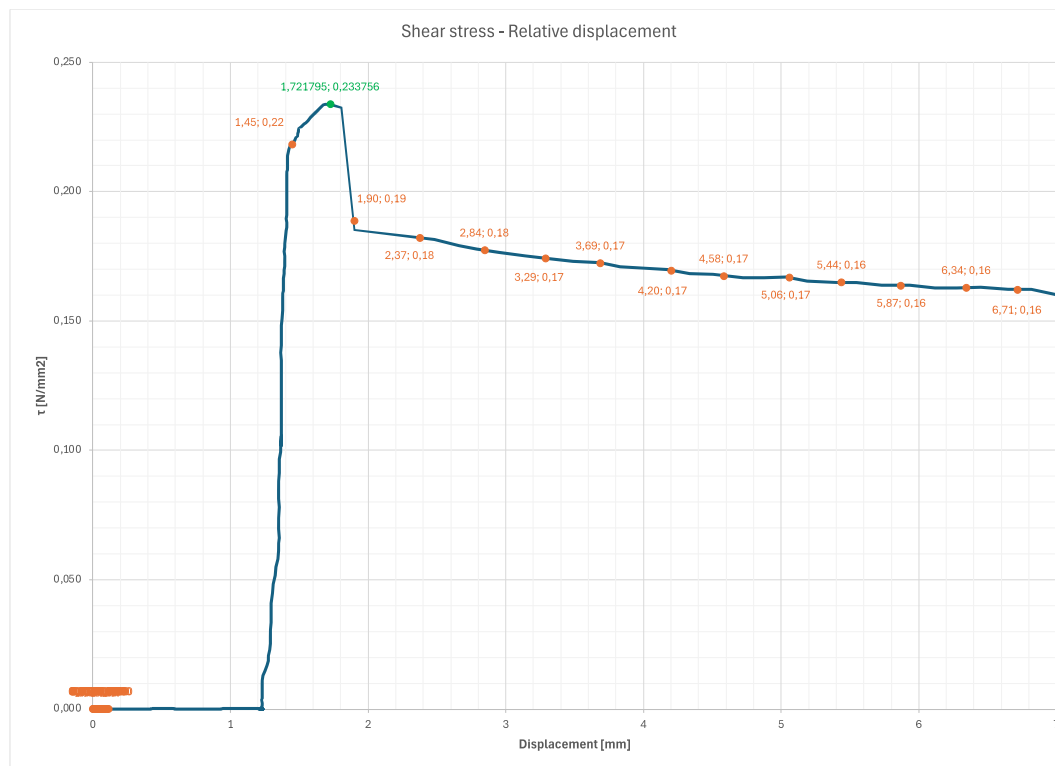
These values were then linked and plotted in an overlapping graph. The orange markers represent the values from each frame in the DIC system, while the blue graph shows the values obtained from the experimental phase. These values were plotted in a shear-stress graph and after converted into a time-relative displacement graph, illustrated in Figure 44 and Figure 45 correspondingly.

Figure 44 : R_DIC and R_DATA combined values for shear stress - relative displacement relation

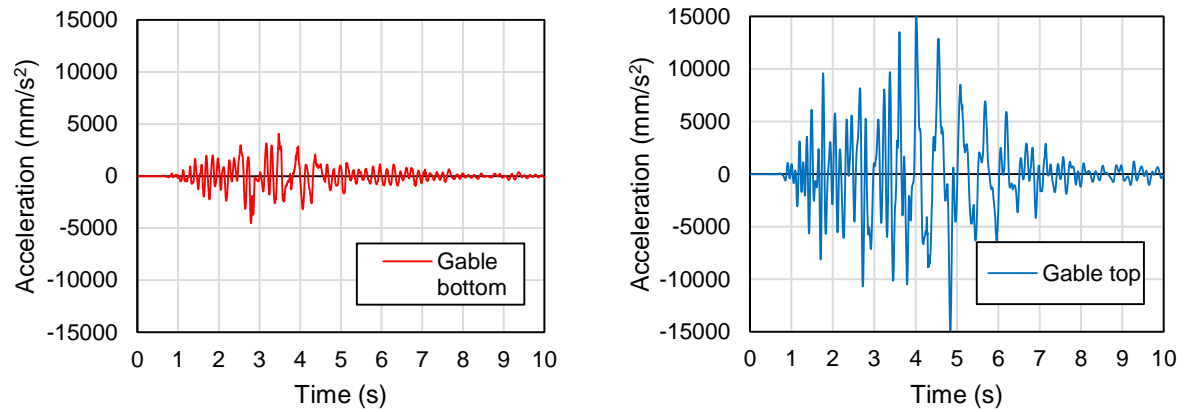
Figure 47 : Accelerogram flexible gable bottom & top

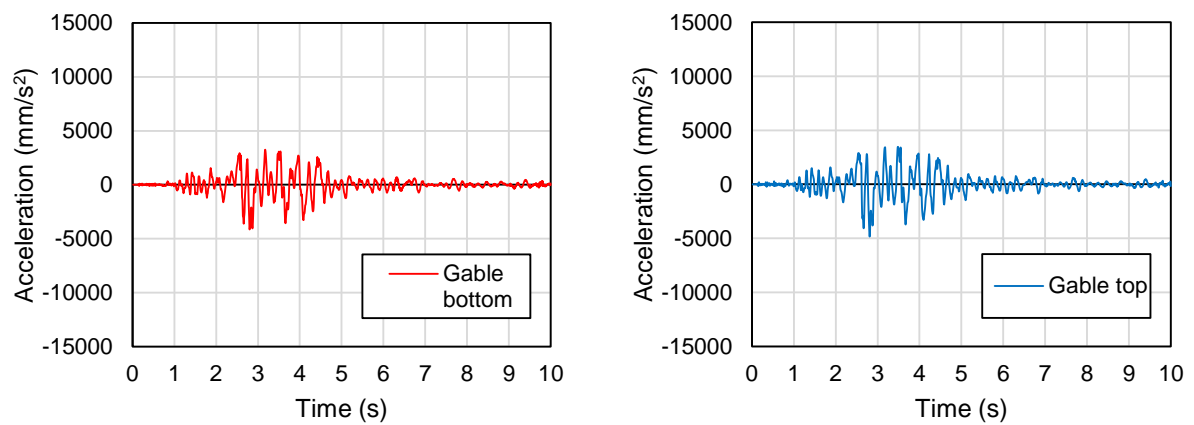
Figure 48 : Accelerogram stiff gable bottom & top

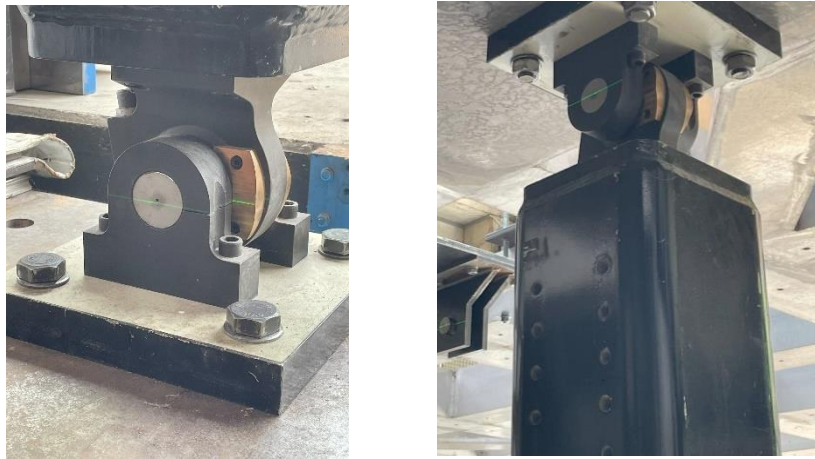
To allow for some movement of the elements, slotted holes have been provided, applying the principle of a mortise and tenon joint. This also facilitates the assembly process. The hinges at the top are secured to the shaking table using plates fastened with eight M20 screw rods, allowing the position to be adjusted to create space for the overhead crane used during the assembly process. The hinges are carefully aligned with the hinges of the shake table's connecting rods, which is essential to ensure the proper load distribution.

Figure 59 : Mortise and tenon joint

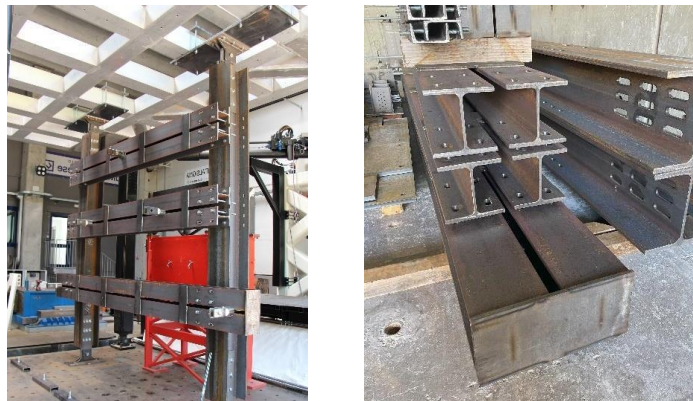
As described within the previous section, calculations were performed on the horizontal elements to determine the maximum deformations. The ends of the longest beam were scaled by welding a steel plate to increase the stiffness of the profile.

Figure 60 : Horizontal steel beams

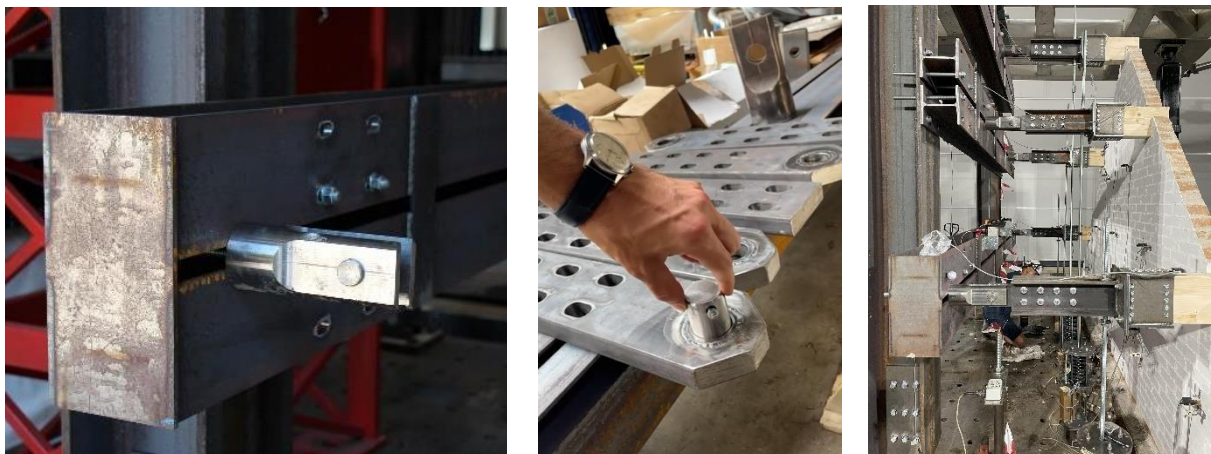
The steel arm consists of three components: a hinge that attaches it to the setup, two UPN140 profiles secured to a plate with an opening for the hinge pin and a bow profile that functions as a support for the purlins. Considering the loads applied by the springs, which will be detailed in the following paragraph, as well as the horizontal force resulting from the dynamic effects on the gable wall, the moment on the arm at the box profile housing the purlin was calculated. Consequently, the shear force on the screws securing it was also determined.

Figure 61 : the components of the loading arms

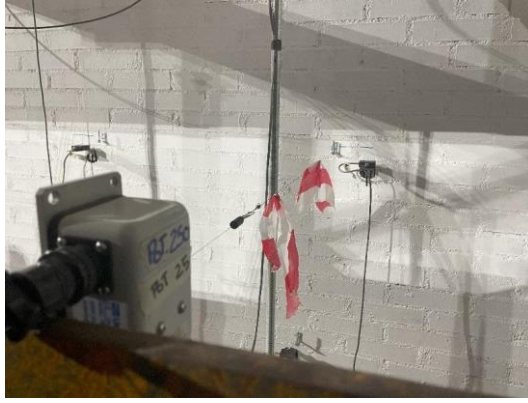
Most potentiometers were attached to a structure positioned behind the façade. This structure, specifically designed for supporting these instruments, serves as a reference point for measuring displacement. It was required that this structure had sufficient stiffness to avoid deformation during testing also this setup was used in previous tests for the same purpose. Certain potentiometers, specifically numbers 23, 24 and 25 as indicated in Figure 71 and Figure 72, were directly attached on the setup itself due to structural obstacles. The relative displacement of the specimen was measured in relation to this setup. By determining the sum of the relative displacements between the setup and the frame, the required absolute displacement was obtained.

Figure 71 : Wire potentiometer measuring the relative displacement of the specimen
