# Development of a post-occupancy assessment method system to evaluate the durability of external cladding of prefabricated timber panels

L A Scrideli<sup>1</sup>, R J G F Oliveira<sup>1</sup>, T O Chiletto<sup>2</sup>, A Ino<sup>1</sup>

<sup>1</sup>Institute of Architecture and Urbanism, University of São Paulo, São Carlos, Brazil

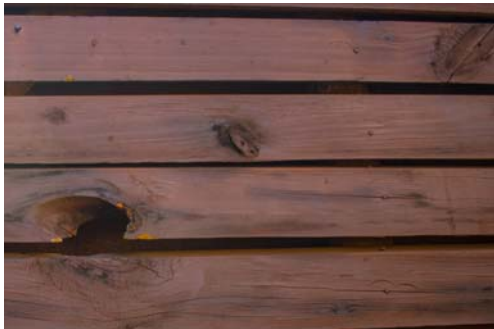
**Figure 3.** Example of wood knots

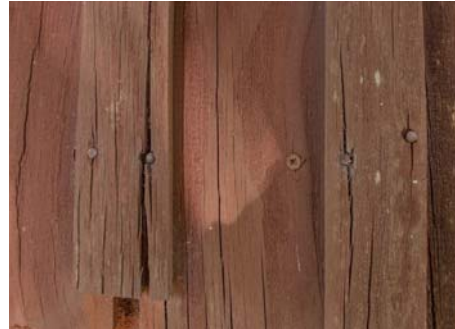
**Figure 4.** Example of cracks

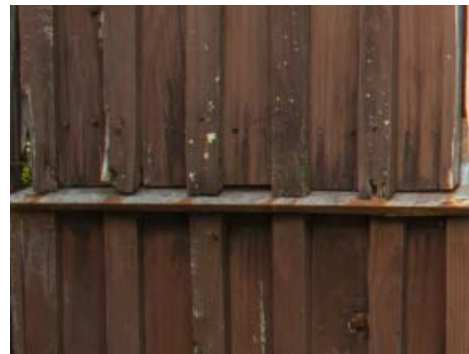
**Figure 6.** Example of sill failure

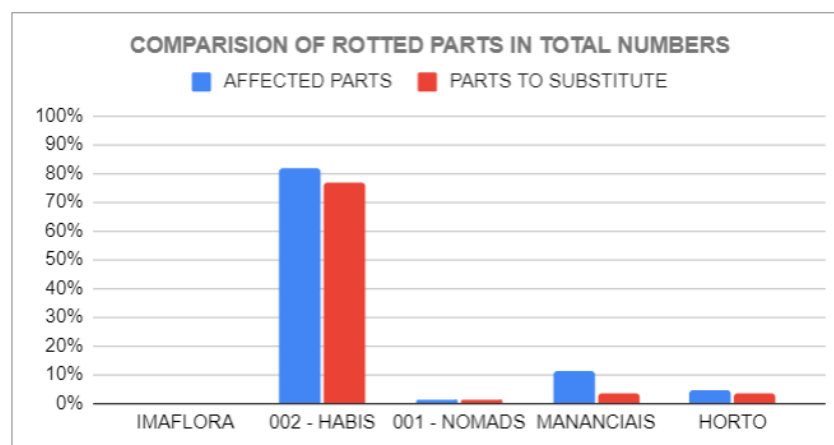
Building	Total parts evaluated	Number of affected parts		Number of parts to be substituted		Affected parts to be substituted
001 – Nomads	309	3	1,0%	3	1,0%	100,0%
002 – HABIS	256	209	81,6%	196	76,6%	93,8%
Casa do Horto	163	7	4,3%	6	3,7%	85,7%
Imaflora	143	0	0,0%	0	0,0%	0,0%
Mananciais	206	23	11,2%	7	3,4%	30,4%

**Figure 17.** Graphic of the comparison of rotted parts in total numbers

The method developed showed that the construction techniques used significantly affect the durability of external cladding panels. Factors such as the type of wood species used, maintenance routine and frequency, material treatment, solar exposure, presence of eaves, and correct project directions all play a crucial role. It is essential to consider these factors to ensure the longevity of the cladding panels.
