Crack Monitoring during Load Testing of Full-Scale Dapped-End RC Beams with Varying Reinforcement Layouts

Luke van Ratingen, Andras Vanquaille, Nadia Amin, Els Verstrynghe,
Boyan Mihaylov, Eline Vereecken, Hervé Degée

Hasselt University – KU Leuven – University of Liège

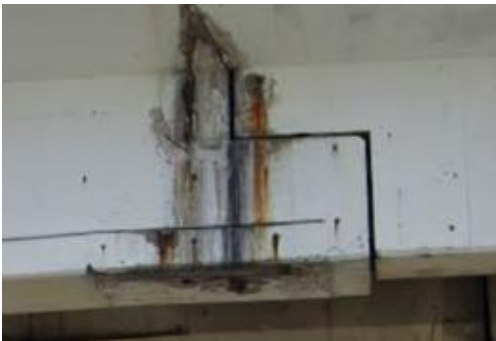
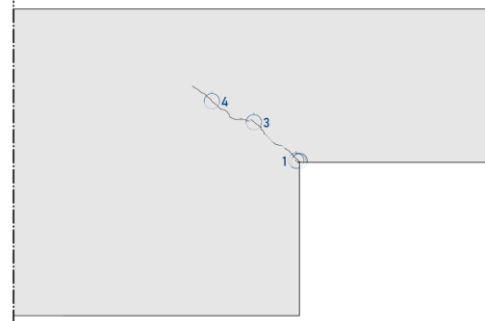
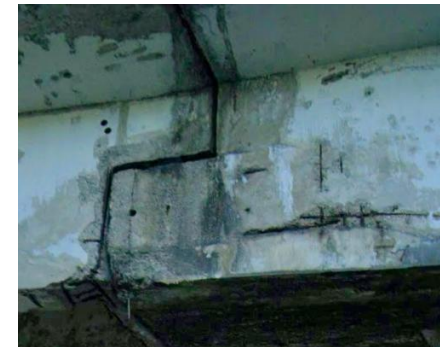
Why Dapped-End Beams Matter

- Dapped-end beams transfer high shear forces
- Re-entrant corner cracks → accelerate corrosion
- Cracking + chloride ingress = rapid loss of capacity
- Limited experimental data exist for aging and deteriorated DE-beams.

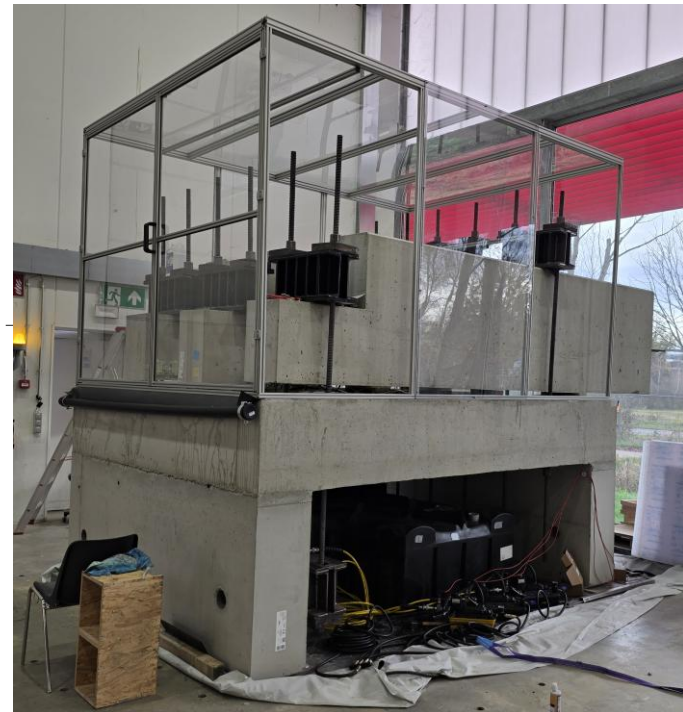
Type test	Phase 1: Reference test	Phase 2: Creep test (3M)	Phase 3: Corrosion test (18 M)
Lightly reinforced DE-beam	RE-L	CR-L	CO-L
Moderately reinforced DE-beam	RE-M	CR-M	CO-M
Heavily reinforced DE-beam	RE-H	CR-H	CO-H

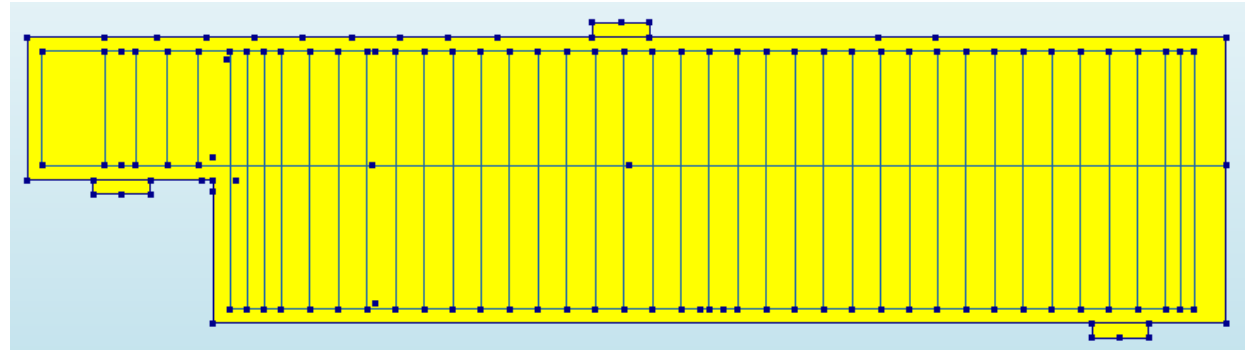
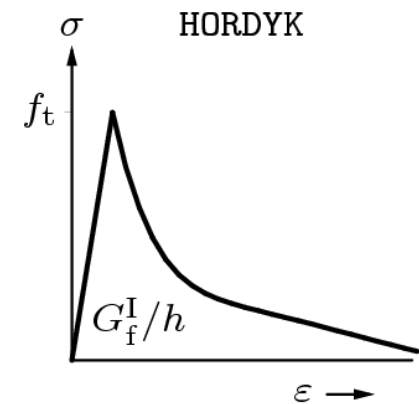
FE - models

- Model properties concrete:
 - Tensile curve: Hordijk
 - Compression curve: Parabolic
 - Reduction model: Vecchio and Collins 1993
 - Stress confinement model: Selby and Vecchio
- Model properties steel:
 - Nonlinear model: Von Mises plasticity
 - Bond-slip* interface failure: Doerr

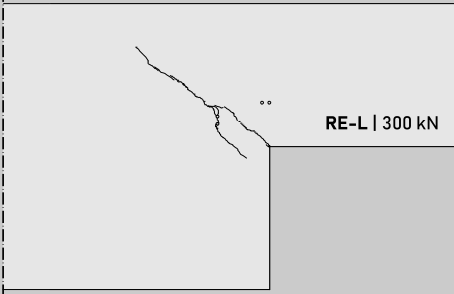
<p>RE-L 300 kN</p>

Load level	RE-L	RE-M	RE-H
50%

<p>RE-H 900 kN</p>
Crack width	0.79 mm	0.49 mm	1.01 mm
Failure

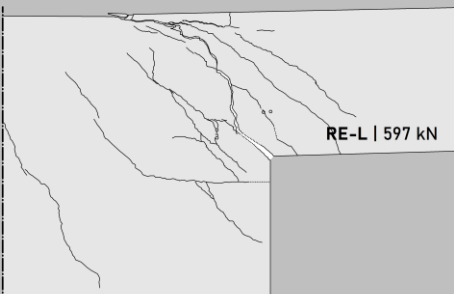
<p>RE-L 597 kN</p>

<p>RE-H 1768 kN</p>
Crack width	2.47 mm	1.6 mm	2.14 mm

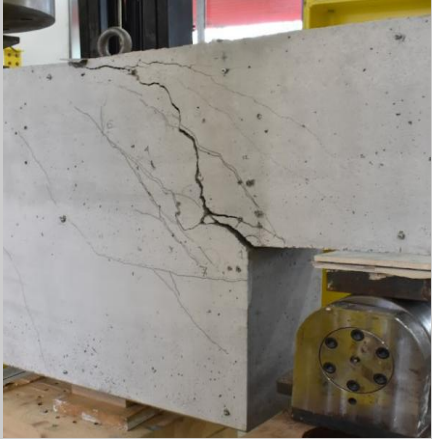
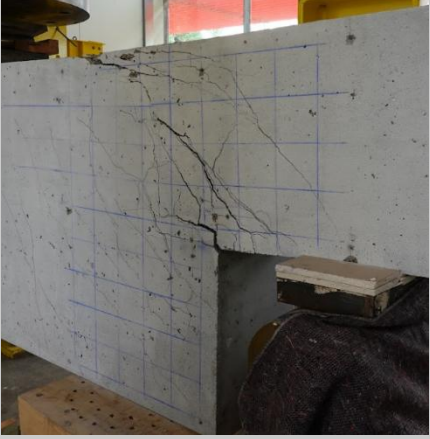
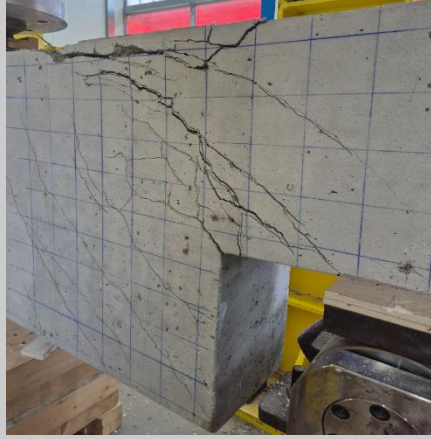
RE-L	RE-M	RE-H
Experiment

RE-H 1768 kN
	Flexural failure	Flexural failure	Flexural-shear failure

- Crack initiation **consistently occurred in the re-entrant corner** region, confirming this location as the governing damage zone.
- **Increasing the reinforcement ratio modified crack propagation** and crack distribution within the dapped-end region.
- **Lightly reinforced** specimens developed **fewer but wider cracks**, whereas **heavily reinforced** specimens showed a **more distributed cracking pattern**.
- **The reinforcement layout influenced** both the **load–displacement** response and the governing **failure mechanism**.
