# **Crack Monitoring during Load Testing of Full-Scale Dapped-End RC Beams with Varying Reinforcement Layouts**

**Keywords:** *Dapped-end beams, Reinforced concrete, Corrosion, Static testing, Failure mechanisms*

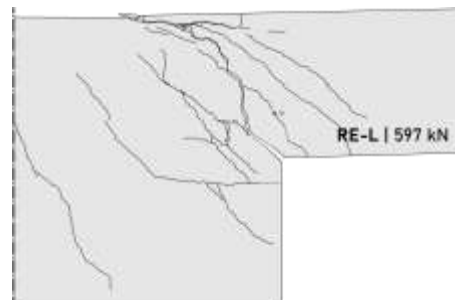
Figure 6. RE-L crack pattern at failure

At 50.2% of the peak load corresponding to a load level of 300 kN for beam RE-L the observed damage state is presented in Figure 5. At this stage of the test, a dominant crack had developed at the re-entrant corner, with a measured maximum crack width of 0.8 mm near the concrete surface. With continued loading, crack widening and propagation intensified, ultimately leading to failure at a maximum load of 597.4 kN. The beam failed due to yielding of the horizontal and vertical reinforcement in the re-entrant corner crack, which caused large plastic rotations of the dapped end about the tip of the crack. The failure load was also affected by rupture of some of the vertical reinforcement in the critical corner crack, which initiated at a load of approximately 480 kN. This failure mode can be described as flexural, as it occurred along the re-entrant corner crack with rotations of the dapped end relative to the full-depth section (Fig. 6).

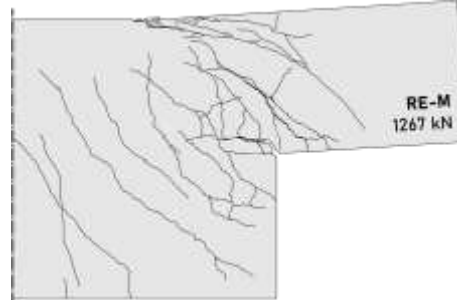
Figure 8. RE-M crack pattern at failure

At 55.3% of the peak load, corresponding to a load level of 700 kN for beam RE-M, the crack pattern observed in the dapped end region is shown in Figure 7. At this stage of the test, cracking was more distributed than in beam RE-L, while a clearly developed re-entrant corner crack was present. The measured crack width at this load level was 0.56 mm. With continued loading, crack propagation and widening intensified, ultimately leading to failure at a maximum load of 1266.5 kN. As evident from Figure 8, similarly to specimen RE-L, this dapped end failed with plastic rotations in the re-entrant corner crack caused by yielding of the horizontal and vertical reinforcement in the crack. Crushing of concrete in the compression zone on the top side of the specimen, as well as ruptures of vertical reinforcement occurred along the plastic plateau of the force-displacement response. These effects limited the ductility of the specimen but did not affect significantly its peak resistance (strength). This failure mode can also be classified as flexural, even though the crushing of the concrete may have been affected by a shear crack from the dapped end. It can be seen in Figure 8 that the crack extended from the inner edge of the loading plate and penetrated the compression zone.

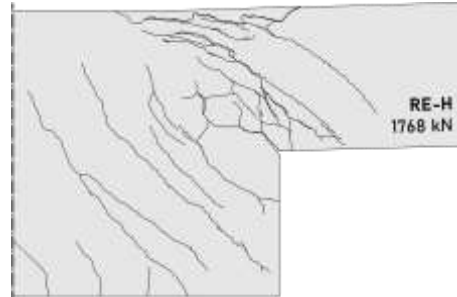
Figure 10. RE-H crack pattern at failure

At 50.9% of the peak load, corresponding to a load level of 900 kN for beam RE-H, the crack pattern observed in the dapped end region is shown in Figure 9. At this load level, a significantly larger number of shear cracks had developed compared to beams RE-L and RE-M, extending not only in the dapped end region but also into the full depth of the beam. This indicates a more distributed shear cracking response, associated with the increased reinforcement. The measured crack width at the re-entrant corner at this load level was 1.01 mm. With continued loading, the beam reached a maximum load of 1768 kN, at which failure occurred due to spalling of the top concrete cover on the top face of the beam, as illustrated in Figure 10. Regardless of the high amount of reinforcement crossing the re-entrant corner crack, the main horizontal and vertical reinforcement yielded in the crack prior to failure. However, compared to specimen RE-M, the concrete in the compression zone crushed earlier along the plastic plateau of the force-displacement response, and the reinforcement did not reach rupture. Concrete cover spalling was also observed at the top of the specimen. Because the re-entrant corner crack and the shear cracks in the dapped end were rather diffused at failure, this failure mode can be characterized as mixed flexural-shear mode.

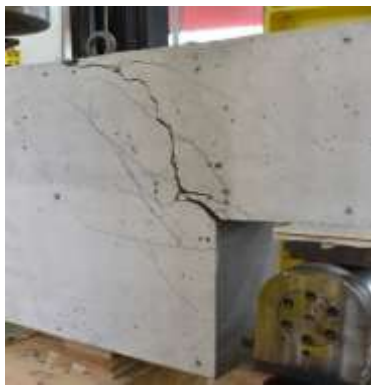
Figure 12. Failure of RE-L

Beam RE-L showed early crack localisation, with a dominant re-entrant corner crack reaching relatively large widths. This localised response reflects the limited amount of reinforcement and resulted in a flexural failure mechanism governed by yielding and partial rupture of the reinforcement crossing the corner crack, accompanied by large plastic rotations of the dapped end (Fig. 12).

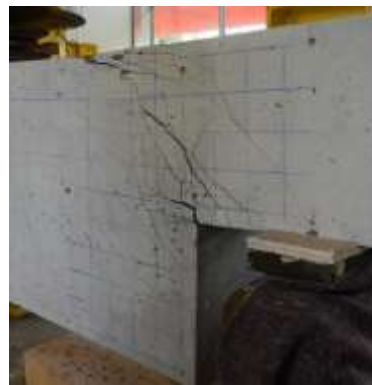
Figure 13. Failure of RE-M

In beam RE-M, the enhanced reinforcement led to a more distributed cracking response in the dapped-end region and a substantial increase in load-carrying capacity. Although a clearly defined re-entrant corner crack still governed the behaviour, crack development was more gradual and the specimen exhibited an extended plastic plateau. Failure was again flexural in nature, controlled by reinforcement yielding in the corner crack, while concrete crushing in the compression zone and local reinforcement rupture reduced ductility without significantly affecting peak strength (Fig 13).

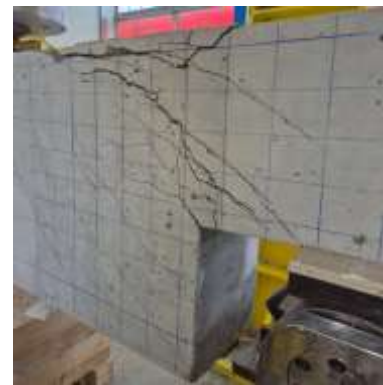
Figure 14. Failure of RE-H

For beam RE-H, the further increase in reinforcement resulted in a markedly different response. Crack patterns became more diffuse, with multiple shear cracks extending from the dapped end into the full-depth section. Despite yielding of the reinforcement at the re-entrant corner, failure was governed by concrete-related mechanisms, including early crushing of the compression zone and spalling of the concrete cover. As a result, the ultimate behaviour can be classified as a mixed flexural–shear failure mode, in which the concrete capacity rather than the reinforcement strength became the limiting factor. The reduced ductility observed for this specimen indicates that increasing reinforcement beyond a certain level does not necessarily enhance structural robustness (Fig 14).
